MILESTONE PHASE 1 CONDITION SURVEY REPORT

Villas de Golf Condominium – Building 4/5
12300 Vonn Rd., Largo, FL 33774

Issue Date: August 25, 2023

**Subject: Milestone Phase 1 Structural Condition Survey Report
Villas de Golf Condominium – Building 4/5
12300 Vonn Rd.
Largo, FL 33774**

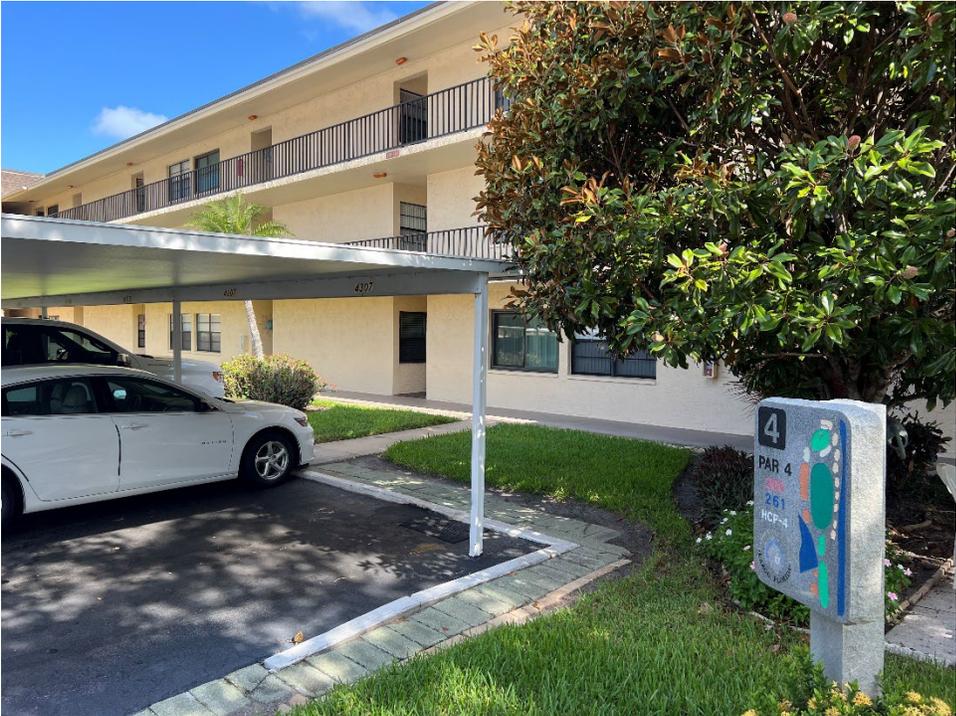
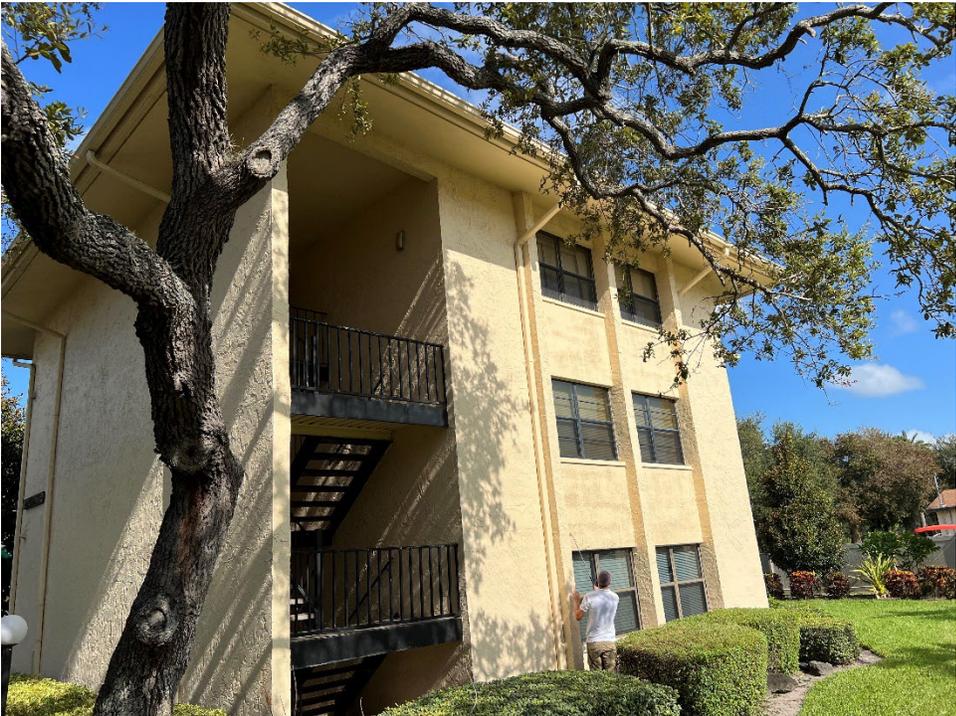
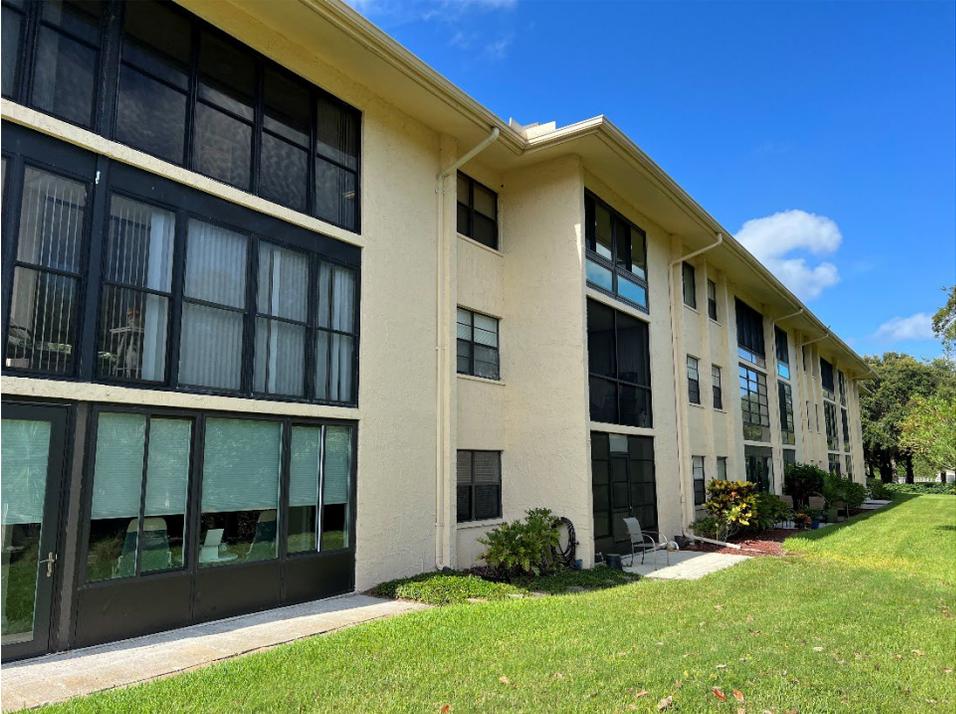
1. Building 4 South elevation, East elevation, and North elevation, exterior wall areas are shown in *Figure A-1* through *Figure A-3*, respectively.
2. Building 5 East elevation, South elevation, and West elevation, exterior wall areas are shown in *Figure A-4* through *Figure A-6*, respectively.

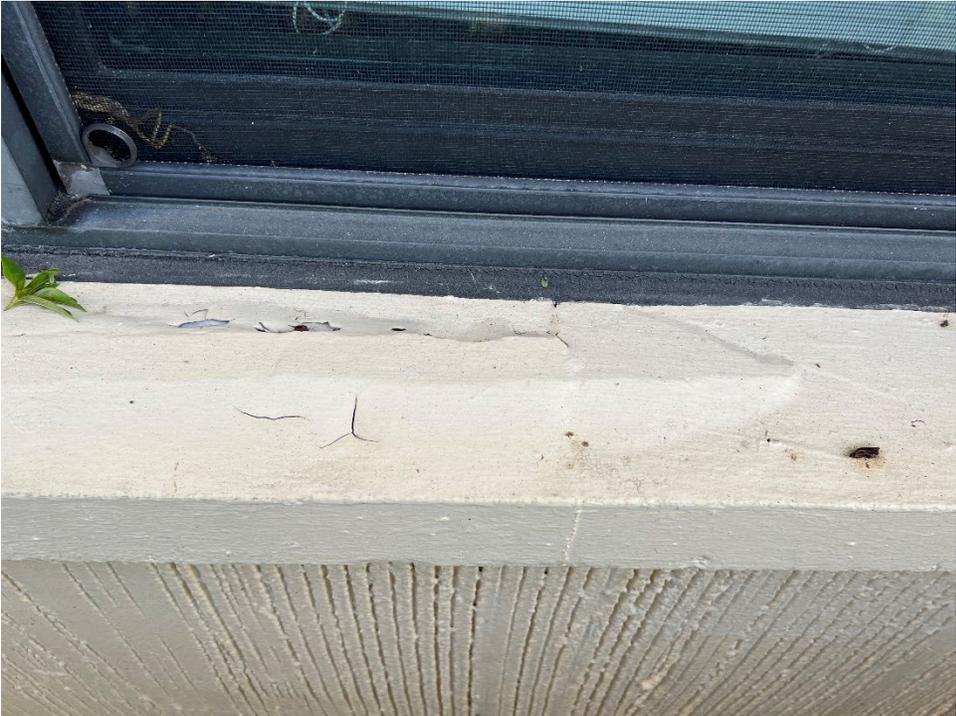
Figure A-7

3. Isolated windowsills exhibited concrete spalling. Refer to *Figure A-7*.
4. A slab edge spall was detected between the metal tube columns. Refer to *Figure A-8*.

Based on the age of the exterior walls since the last paint project, sporadic wall delaminations at accessible locations, and the deterioration of sealants at the perimeter of windows, BillerReinhart recommends a restoration and painting project be undertaken for the repair and maintenance of all the exterior wall surfaces including deteriorated concrete structural elements, stucco, sealants, and building painting. Restoration of the exterior wall areas should mitigate potential moisture intrusion and expose any structural deterioration of underlying structural elements in need of repair. BillerReinhart recommends the exterior wall restoration and waterproofing project be undertaken within the next 1-2 years.

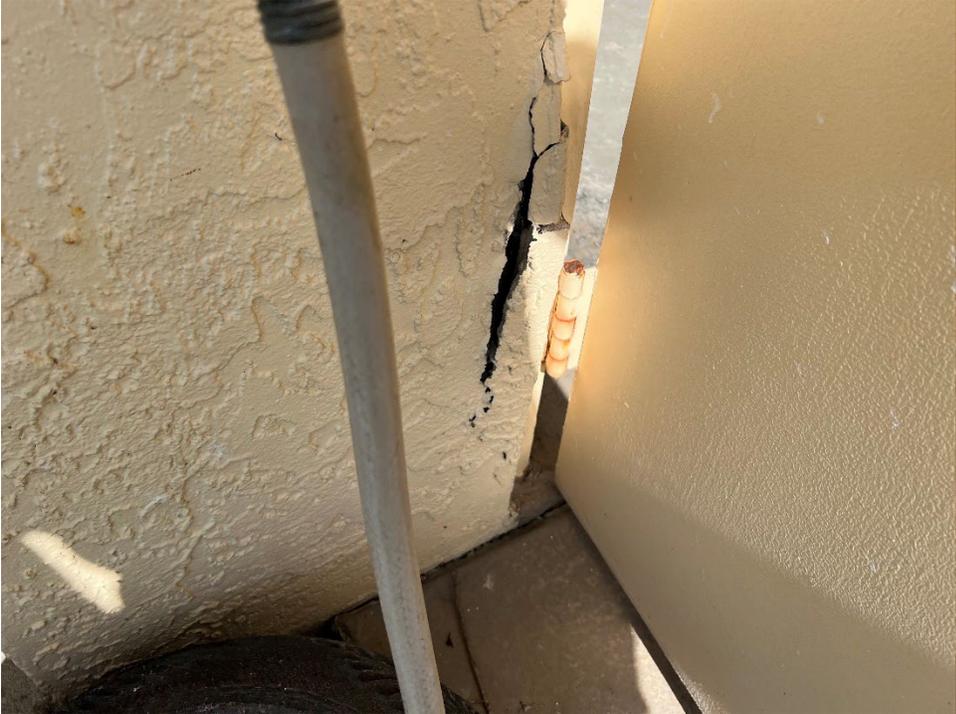
Figure A-9

5. A concrete spall was observed near the door frame of the trash room. Refer to *Figure A-9*.
6. Isolated areas of stucco delamination were detected throughout the accessible areas of the exterior walls. Refer to *Figure A-10*.

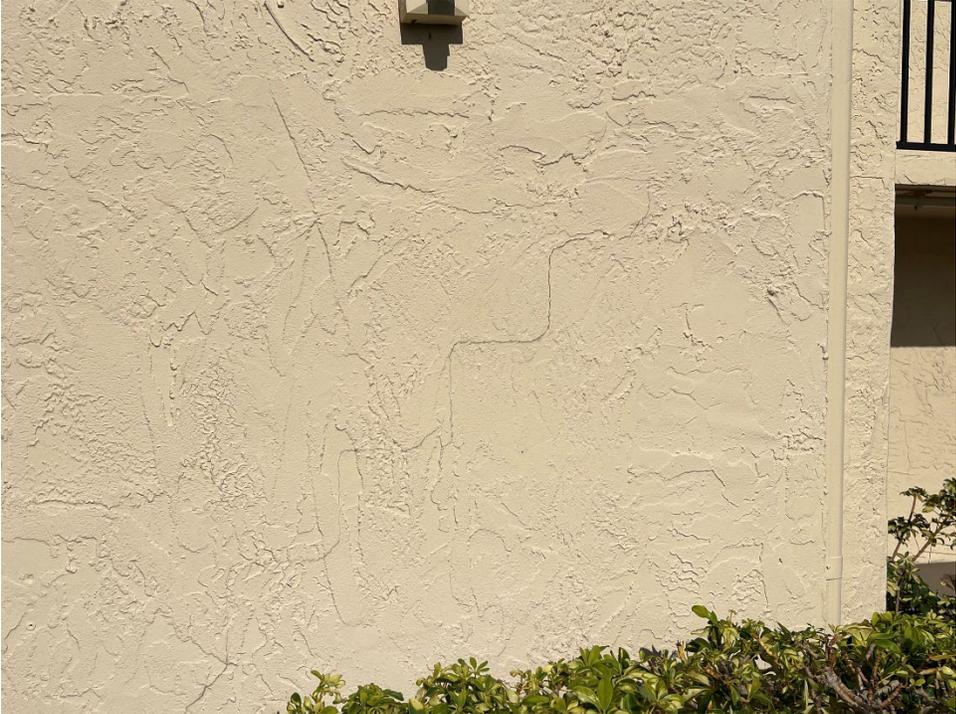
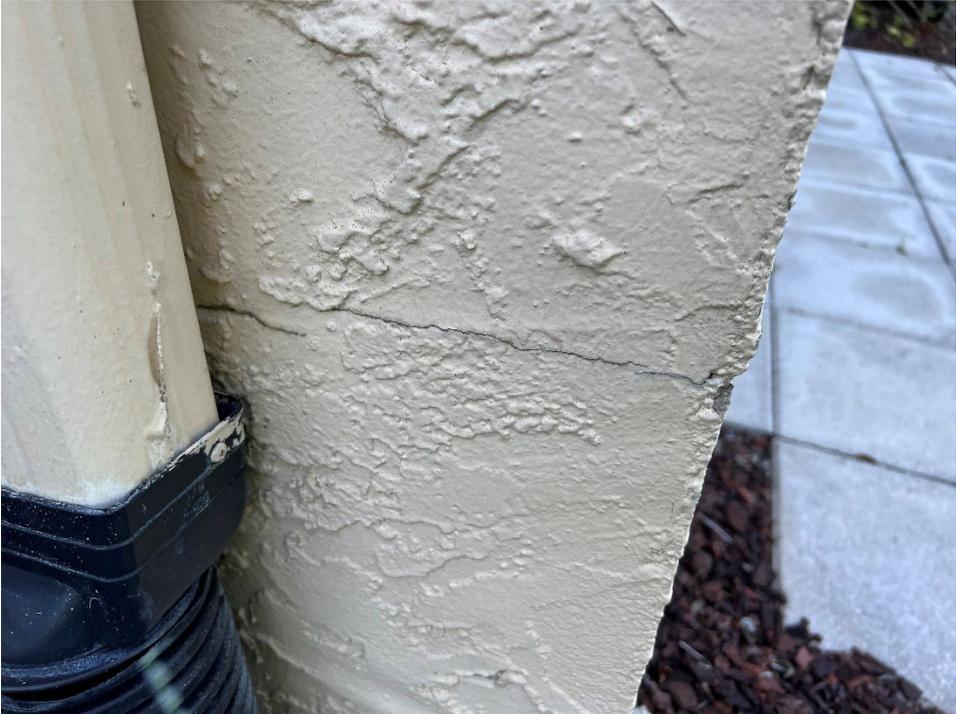
7. Sporadic areas of hairline cracks were observed throughout the buildings. Refer to *Figure A-11* and *Figure A-12*.
8. Deteriorated sealants were observed around the perimeter of windows throughout the buildings. Refer to *Figure A-13*.

- iii. Delaminated areas, spalls, and exposed metal in vertical concrete wall surfaces.
 - iv. Concrete crack repair via epoxy injection - cracks in wall surfaces having widths equal to or greater than approximately 1/16".

- v. Concrete crack repair via routing and sealing with sealant for cracks in concrete wall surfaces having widths less than 1/16" (non-structural cracking).

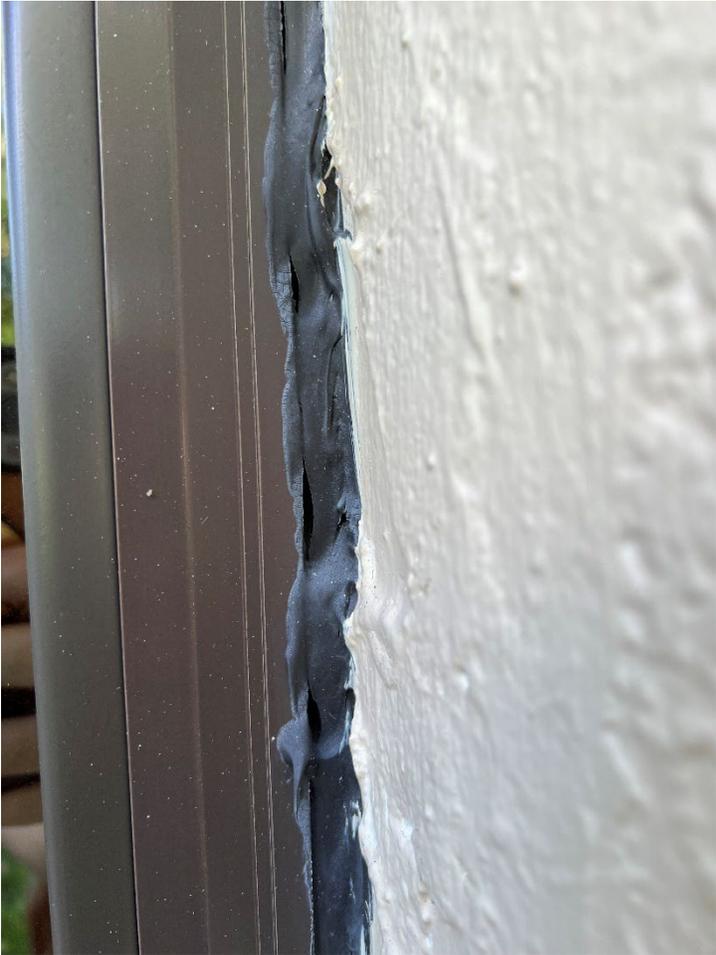
Figure A-14

9. Gaps were observed in the sealant around window perimeters. Refer to *Figure A-14*.

- a. All perimeter window seals for the unit window systems, common element window system perimeters.
 - b. Perimeter seals for door frames, aluminum louvered vent frames, miscellaneous accessories penetrating wall finishes (light fixtures, etc.),

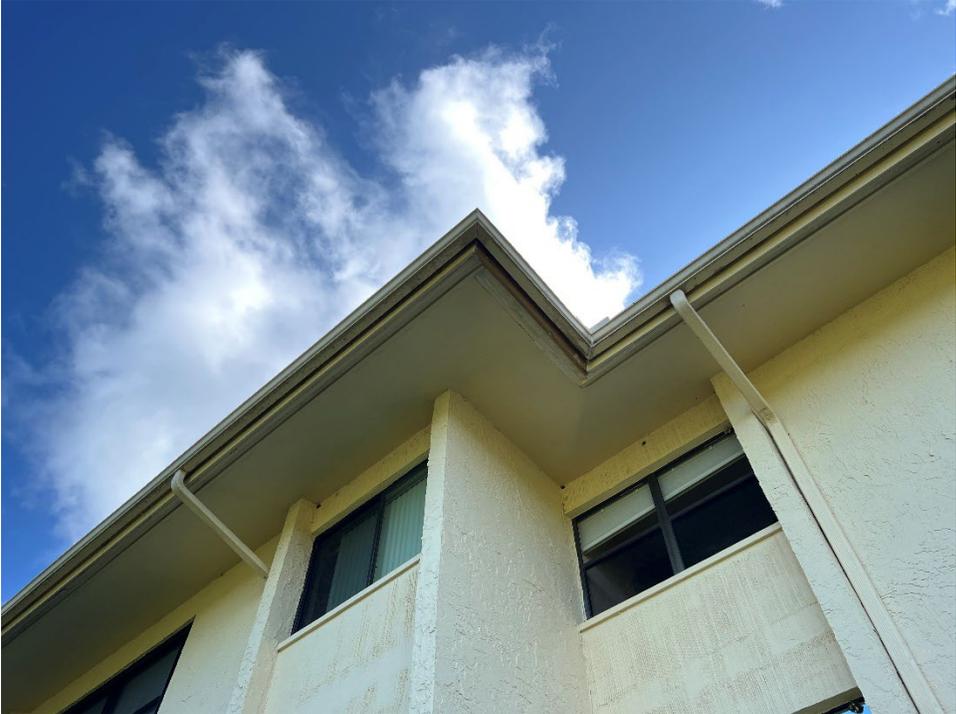
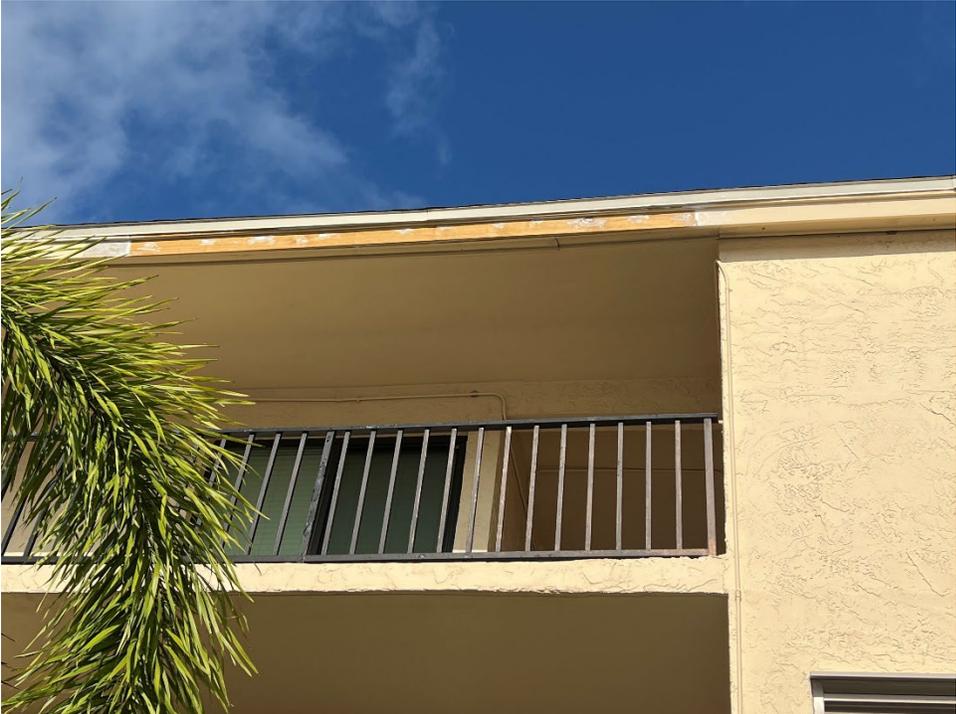
10. Unpainted fascia boards were noted throughout the buildings. Refer to *Figure A-15 and Figure A-16*.

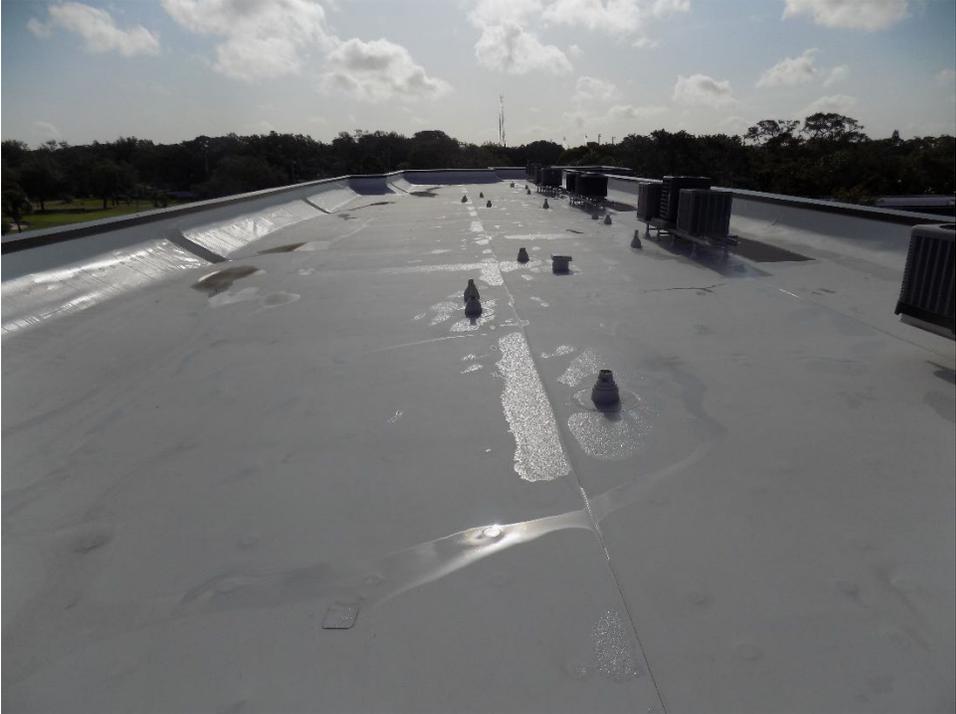
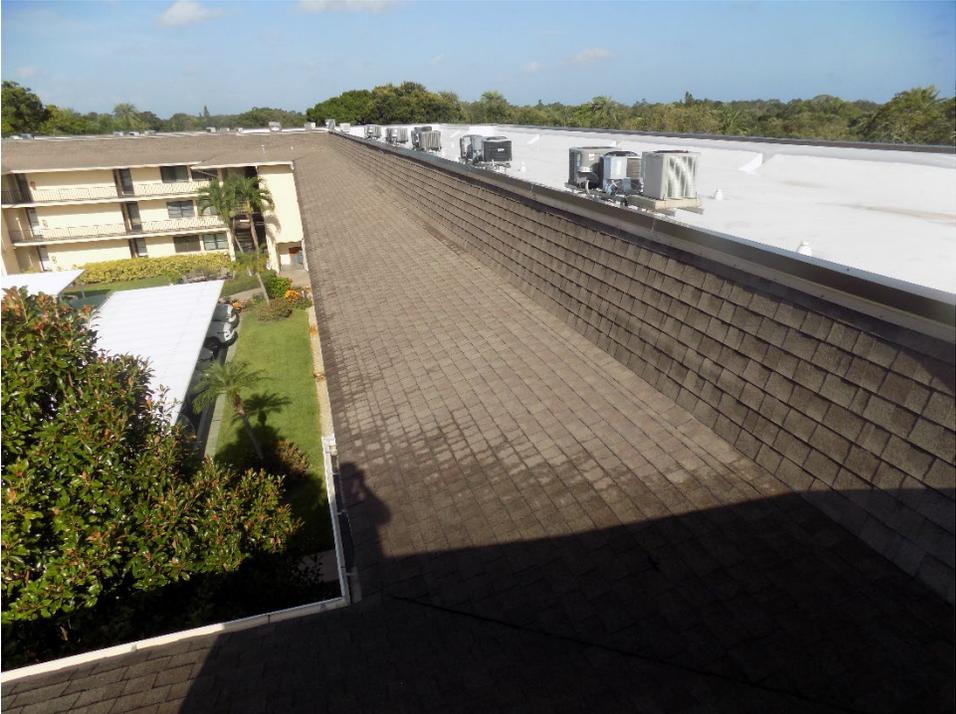
1. Overall general conditions of the roof are shown in *Figure A-17 and Figure A-18*.
2. Multiple shingle with granule loss, exposed fibers, and section loss were observed throughout the roof. Refer to *Figure A-19 and Figure A-20*.
3. Sporadic areas of replaced shingles were observed throughout the roof. Refer to *Figure A-21 and Figure A-22*.

The roof systems were generally observed to be in good condition with no reports of water intrusion. BillerReinhart understands, construction was completed in 2022 for the roof over with a TPO roof surface with a life expectancy of approximately 20 years and the mansard shingle roof replacement project is planned to start in the following year. BillerReinhart recommends the main TPO roof system be monitored and a replacement project be planned for approximately 2042 and recommends continuing with the planned replacement project of the mansard shingle roof with in the following year.

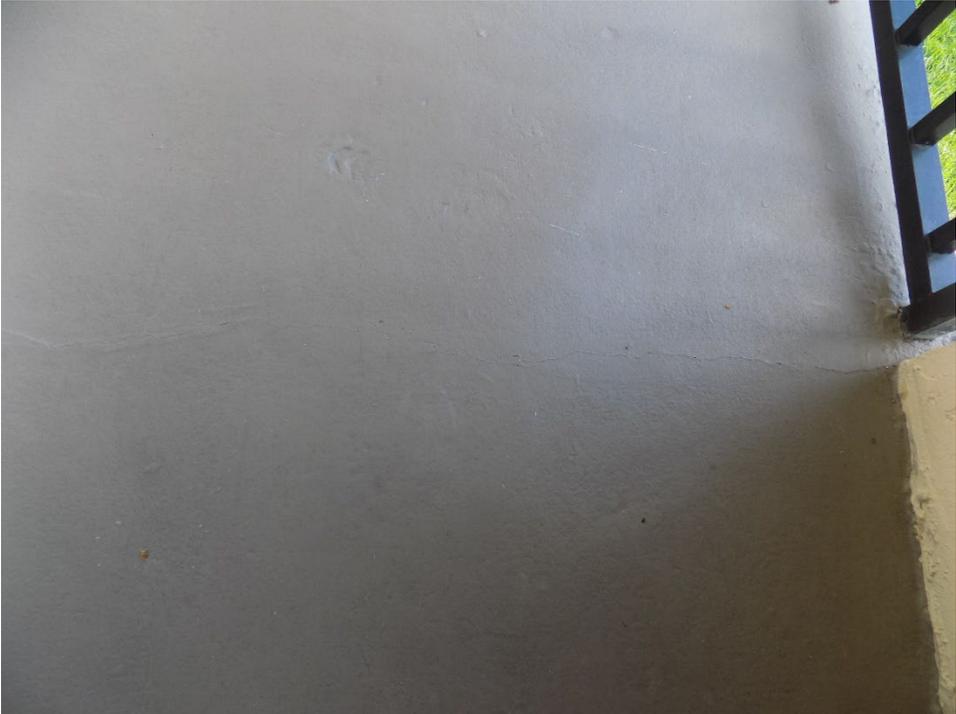
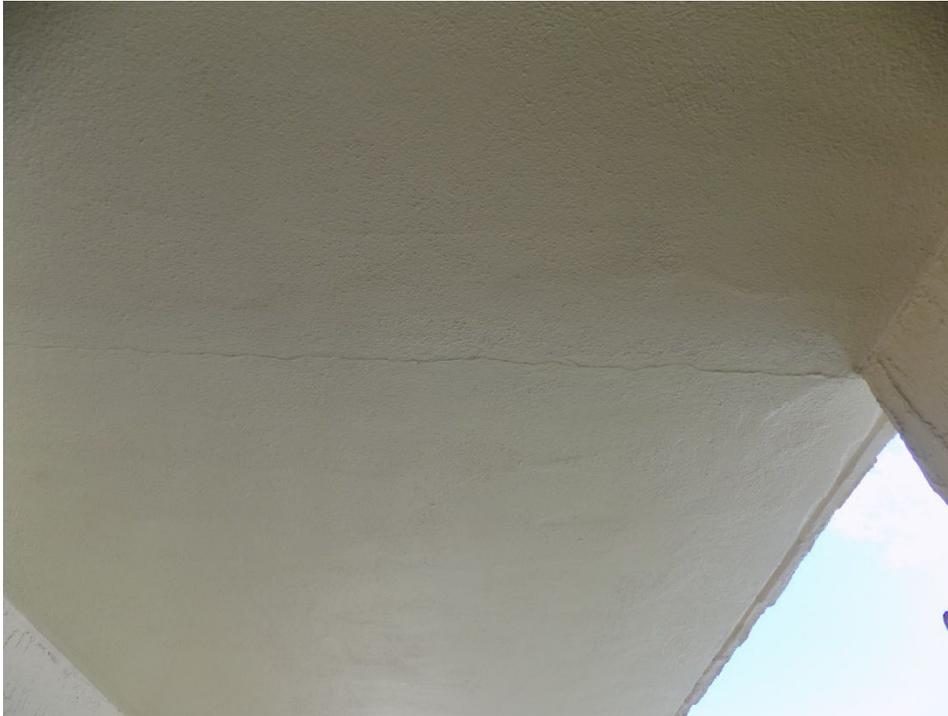
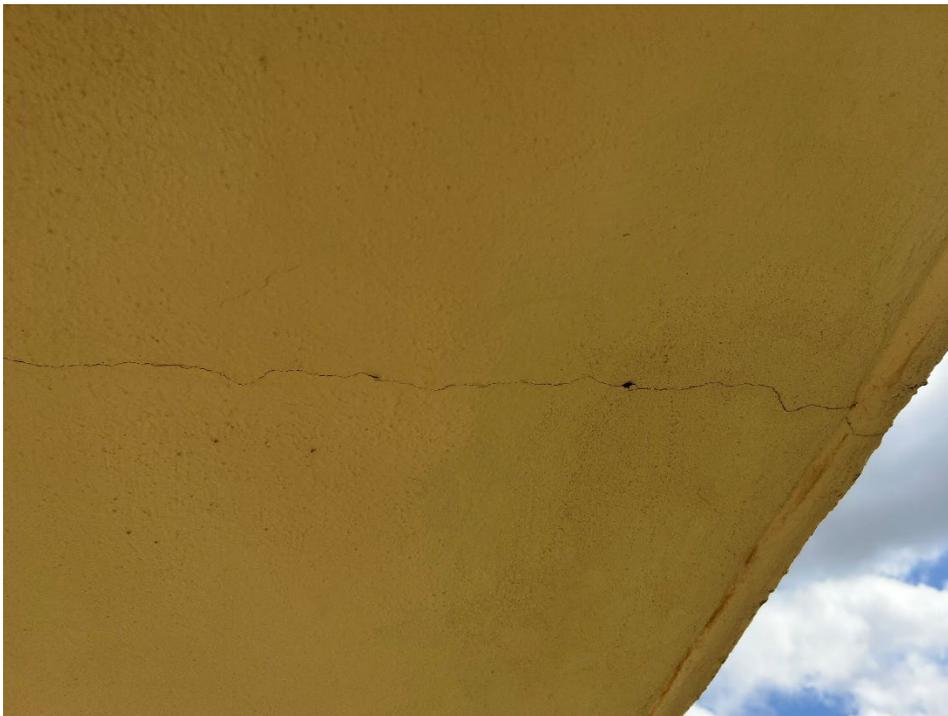
1. The walkways appear to be covered with coats of paint.
2. The exterior entry areas to unit doors and to the elevators appear to be finished with carpet.
3. The guardrails appear to be mechanically attached aluminum guardrails.
4. Sporadic concrete spalls were observed throughout the walkway slabs, slab edges and ceilings. Refer to *Figure B-1 through Figure B-5*.
5. Multiple delaminations were detected on the ceilings throughout the walkways.
6. Multiple cracks were observed on the walkway slabs and ceilings. Refer to *Figure B-6 through Figure B-8*.

The walkway structures generally appear to be in fair condition, with multiple slab and ceiling concrete spalls and delaminations. BillerReinhart understands a painting project for the walkways slabs is planned to start in the following year. However, BillerReinhart recommends a restoration and waterproofing project with a urethane waterproofing

membrane be undertaken for the elevated walkways. Urethane waterproofing membranes can withstand the pedestrian traffic that occurs on the balconies and provides the flexibility to expand and contract with the building movements to better protect the concrete structure from potential moisture intrusion and any structural deterioration of underlying structural elements including the steel reinforcement. BillerReinhart recommends the board plan for a walkway restoration and waterproofing project within the next 1-2 years.

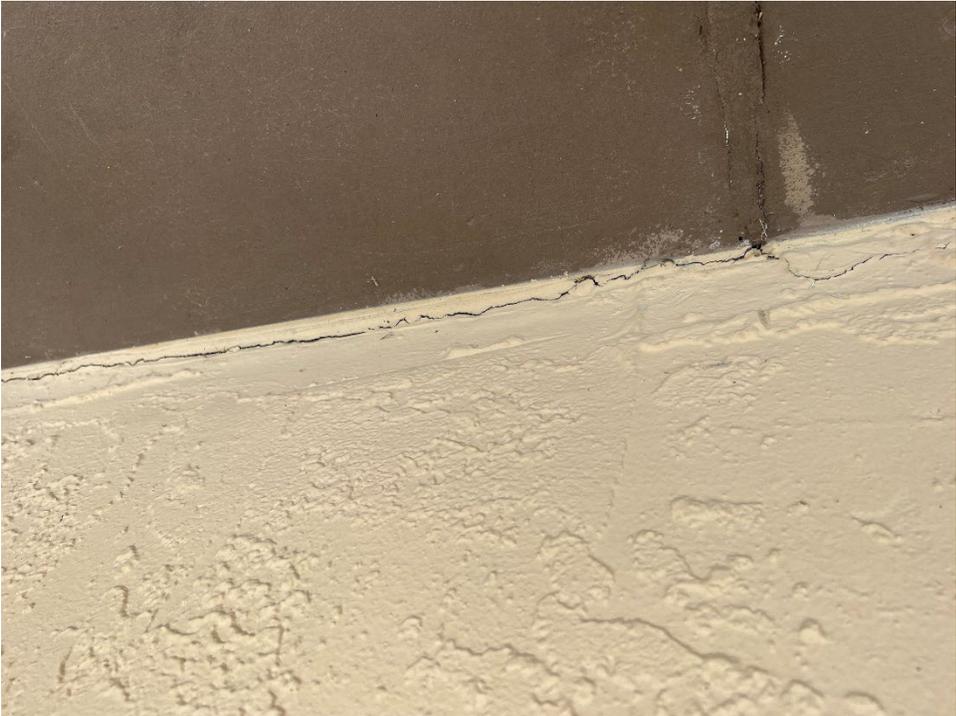
Figure B-9

7. Isolated areas of stucco delaminations were detected on the exterior walls of the walkways. Refer to *Figure B-9*.
8. Peeling paint was observed on isolated areas of the walkway slabs. Refer to *Figure B-10*.
9. Guardrail post pockets were noted to be failing. Refer to *Figure B-11 and Figure B-12*.
10. Supplementary connections were observed to be used to connect the guardrails to the walls. Refer to *Figure B-13 and Figure B-14*.
11. Corroded fasteners were observed on the guardrail picket connections. Refer to *Figure B-15*.
12. Areas on the guardrails were observed to have peeling and deteriorating paint. Refer to *Figure B-16 through Figure B-18*.
13. The guardrail height appears to be approximately 36 inches and picket spacing of approximately 5 inches.

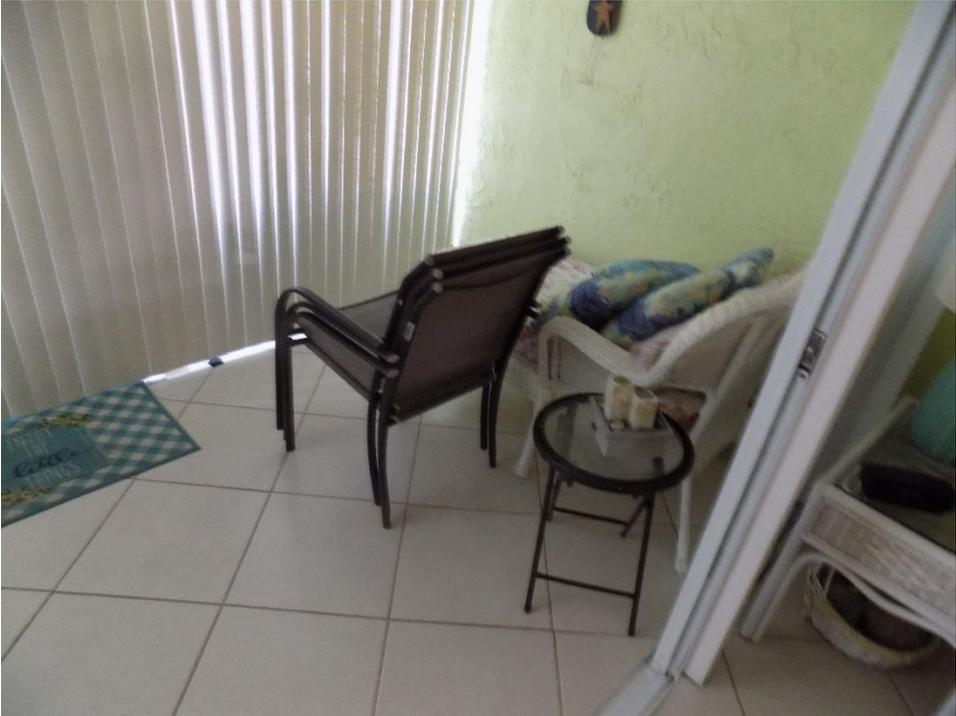
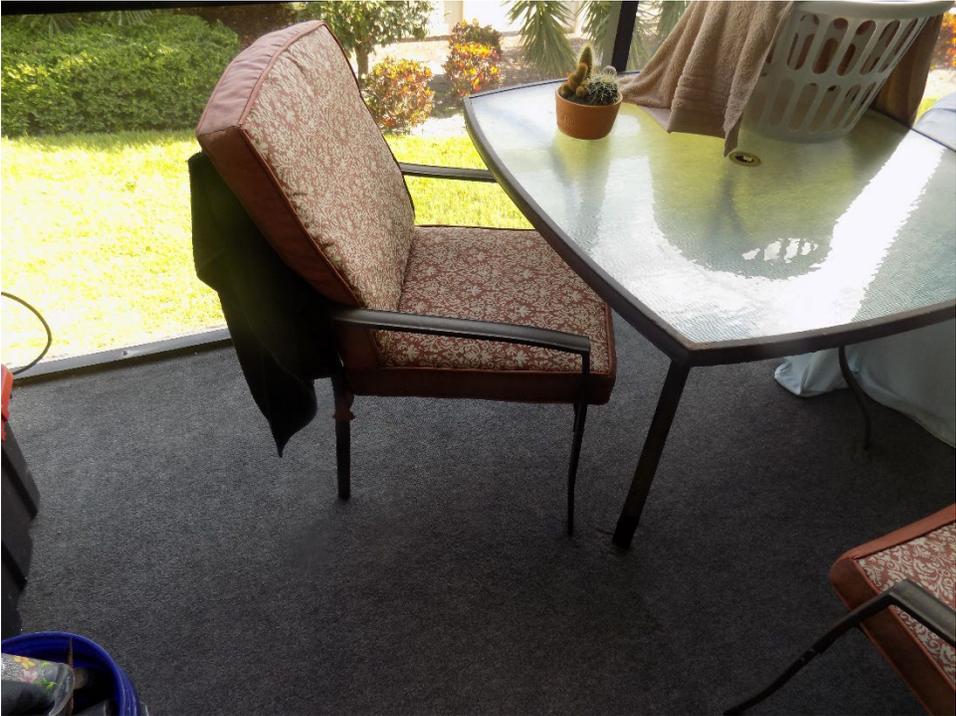
1. A majority of the lanais appear to be enclosed and covered with tile or carpet. Overall general conditions of the lanais are shown in *Figure B-19 and Figure B-20*.

The surveyed balcony structures were observed to generally be in good condition. Since majority of the lanai's have been enclosed, they will not experience exposure to external environmental conditions which can adversely affect the structural elements. Any lanai areas that are exposed to the exterior conditions should be maintained with procedures consistent with the recommendations for the exterior walkways, with periodic restoration and replacement of waterproofing membranes on the horizontal surface of the lanai slab.
