# Villas de Golf Condominium Association, Inc.

Inspected: January 31, 2024 • Revised on: December 05, 2024  
Largo, FL

STRUCTURAL INTEGRITY  
RESERVE STUDY

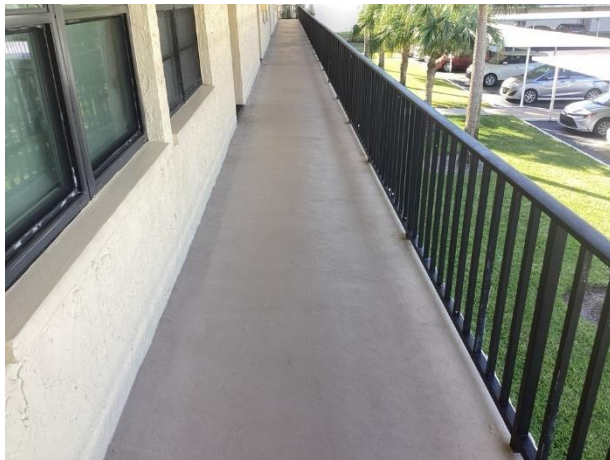
**Condition:** Fair overall with isolated concrete damage, cracks and membrane deterioration evident.

**Breezeway overview**

**Useful Life:** Capital repairs including a close-up visual inspection, patching of delaminated concrete, routing and filling of cracked concrete, and waterproof coating applications every 8- to 12-years.

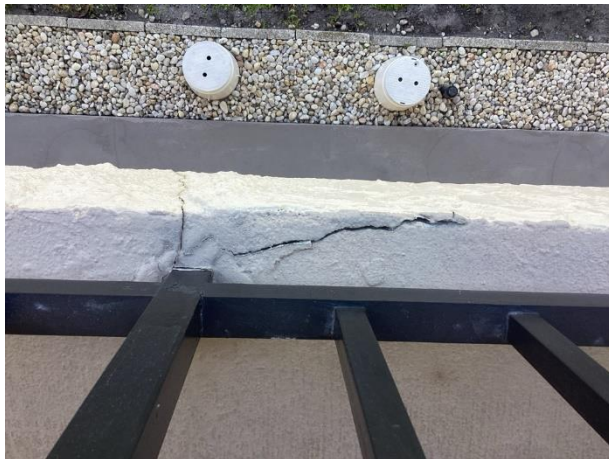
**Concrete edge cracks by unit 8206**

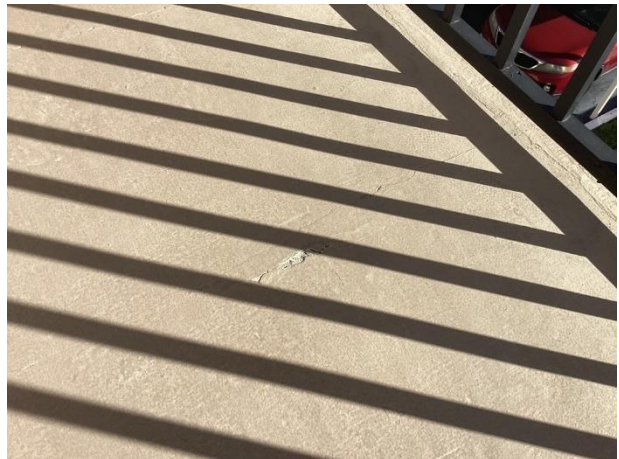
**Breezeway damage by unit 5304**

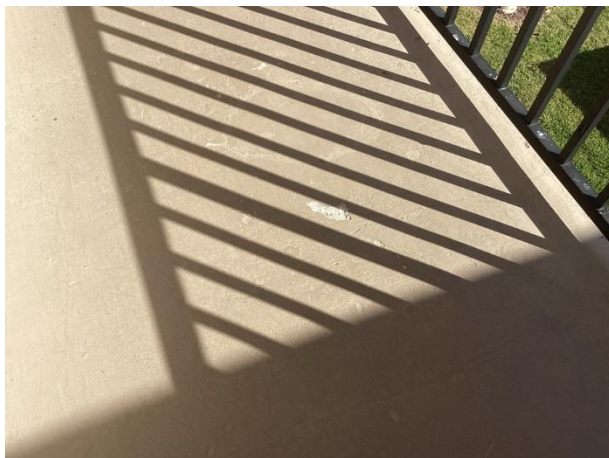
**Breezeway damage**

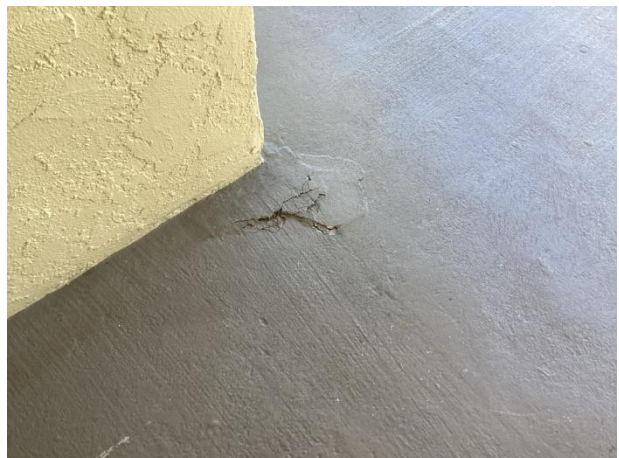
**Concrete damage by unit 3201**

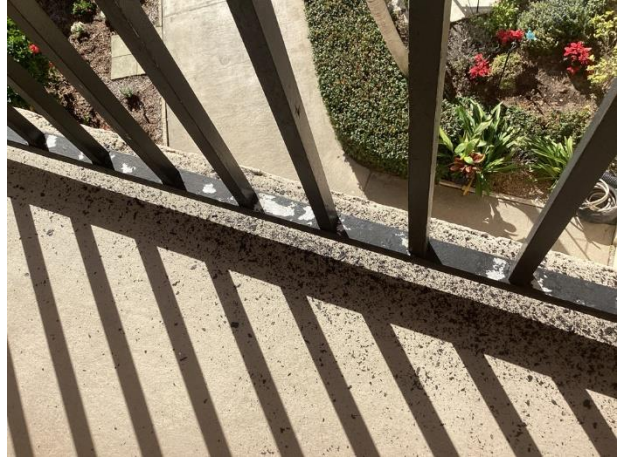
**Aluminum railings being repaired**

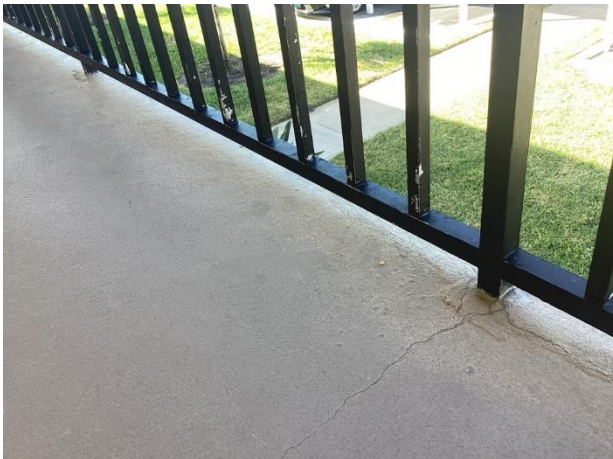
**Conditions:** The railings are in fair overall condition and the railing finishes are in poor condition with rust and peeling finish evident.

**Cracks and previous repairs at breezeway railing posts**

**Useful Life:** Railings of this type have a useful life of up to 50 years with the benefit of periodic maintenance. Periodic maintenance should include applications of a protective paint finish and partial replacement of deteriorated aluminum every five- to seven-years.

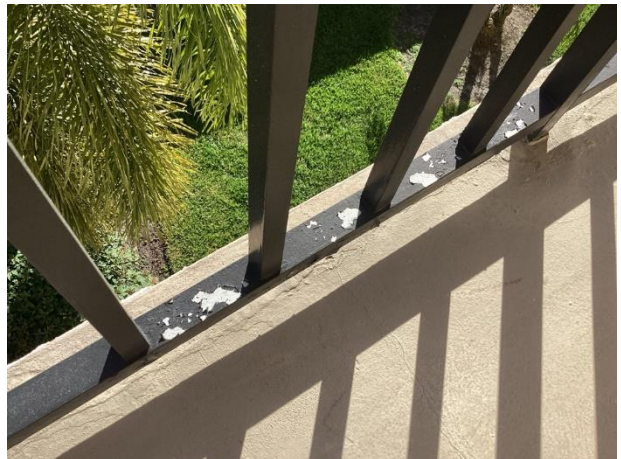
**Peeling paint finish at breezeway**

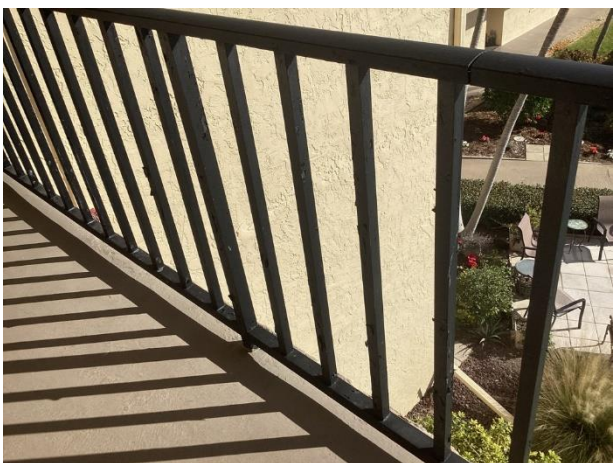
**Railing finish deterioration**

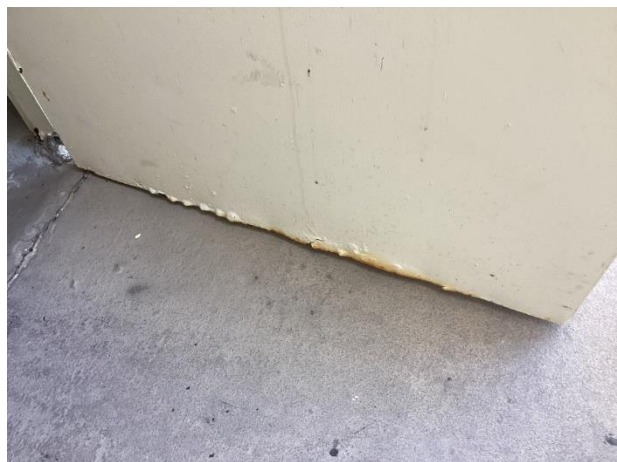
**Condition:** Good to fair overall with isolated rust evident

Door rust at building 7 trash room

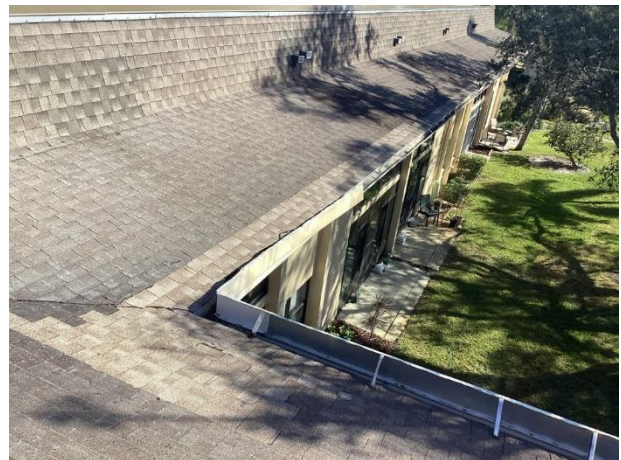
**Condition:** Fair overall with missing shingles and previous repairs evident.

Residential roof with previous repair along edge

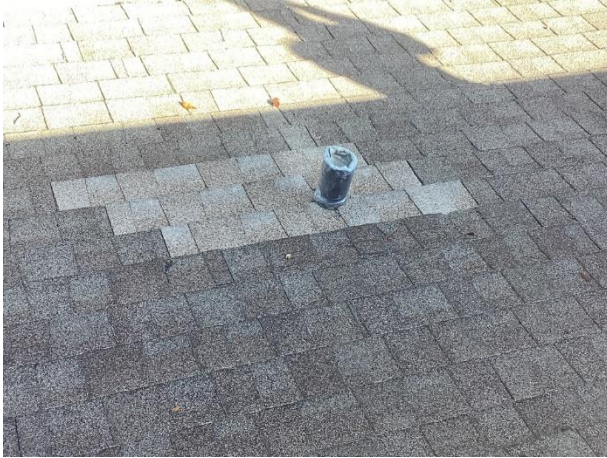
**Previous repair at roof penetration**

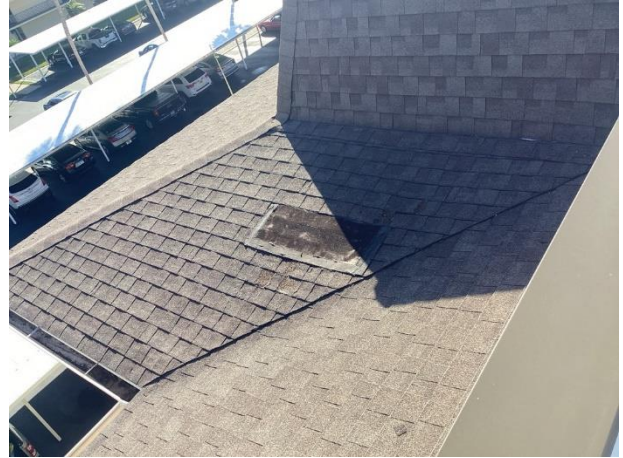
**Missing shingles at building 5**

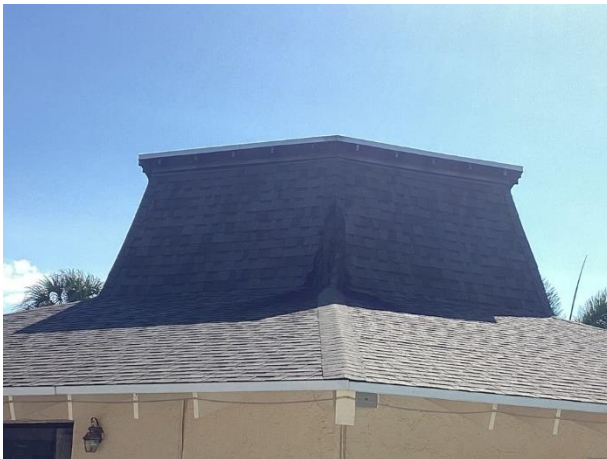
**Clubhouse roof with worn shingles**

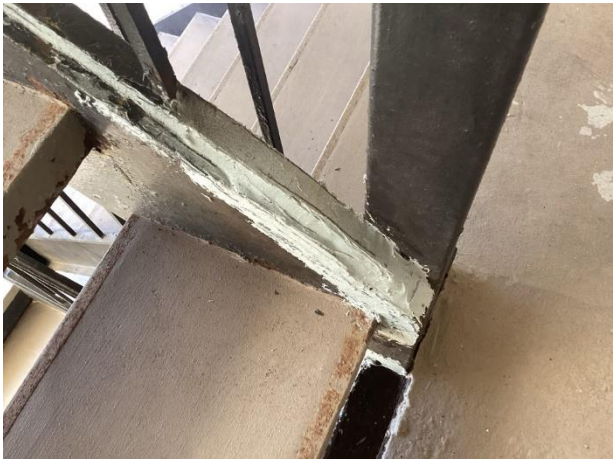
**Condition:** Fair overall with rust formation evident.

**Metal staircase being repaired**

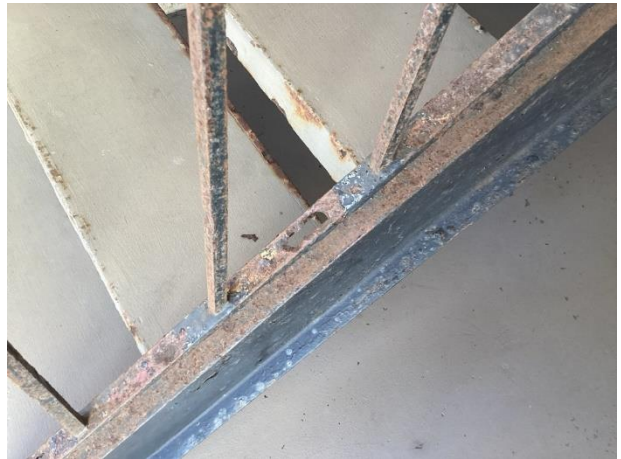
**Rusted through railing at unit 3106**

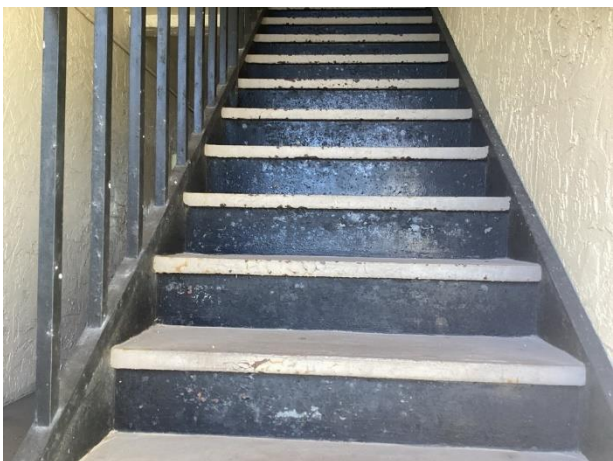
**Staircase with rust by unit 8101**

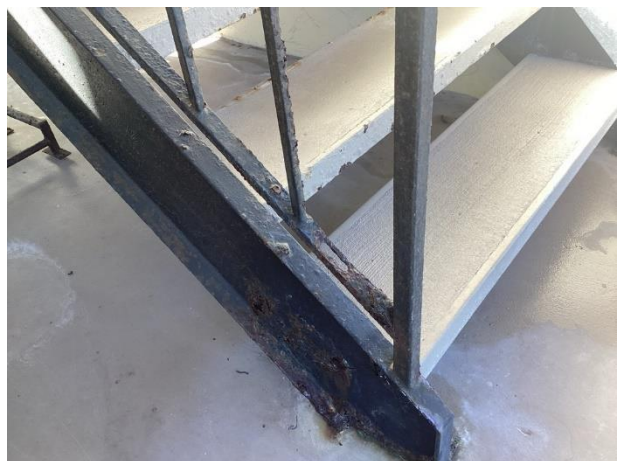
**Staircase rust by unit 2101**

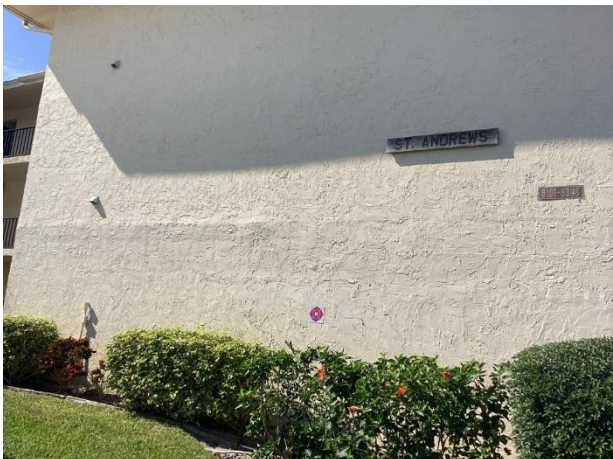
Evidence of potential moisture intrusion

**Useful Life:** We recommend inspections, repairs and paint finish applications every up to 10 years.

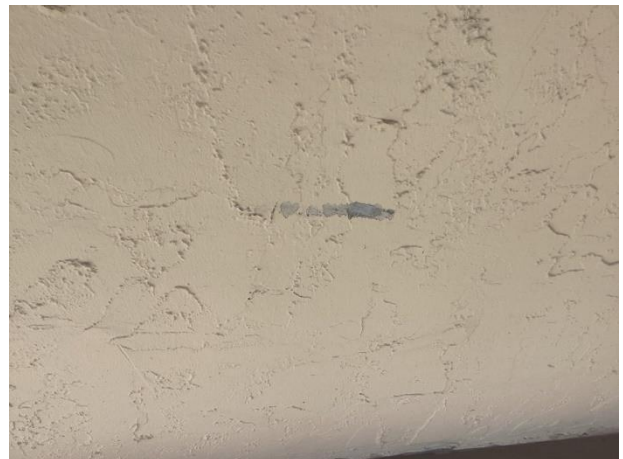
Stucco damage at unit 1102

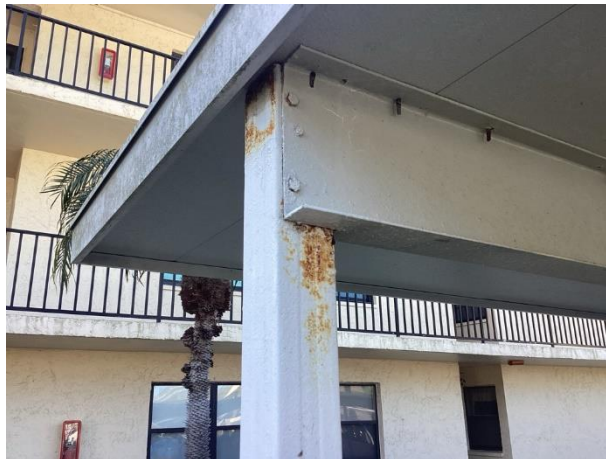
**Condition:** Good to fair overall with rust at post evident

**Rust at old carport post**

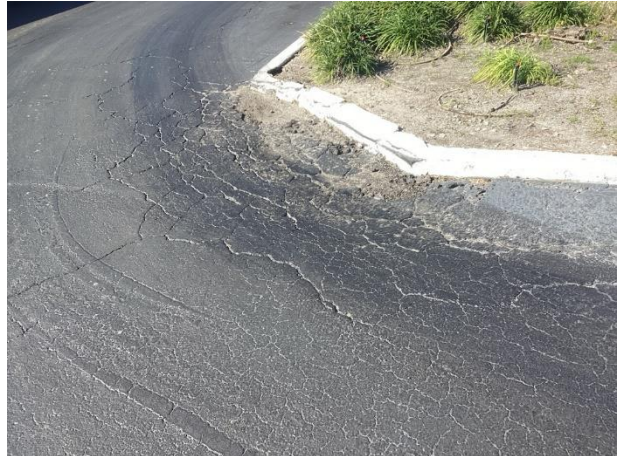
**Condition:** Fair overall with systemic cracks and patches evident.

Pavement cracks

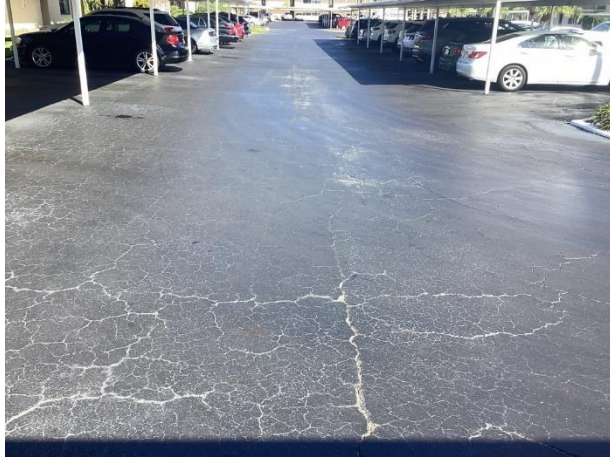
**Pavement with cracks**

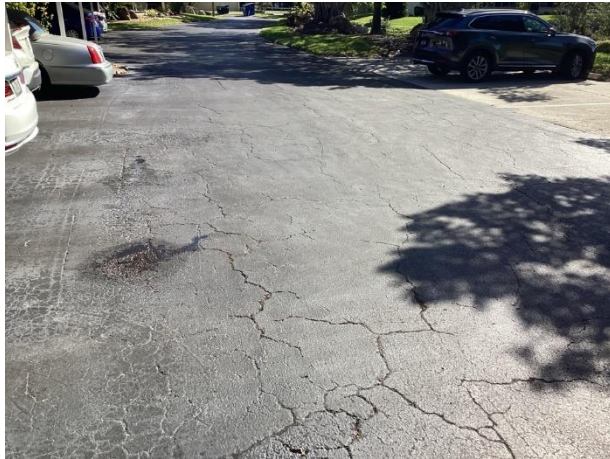
**Pavement with cracks**

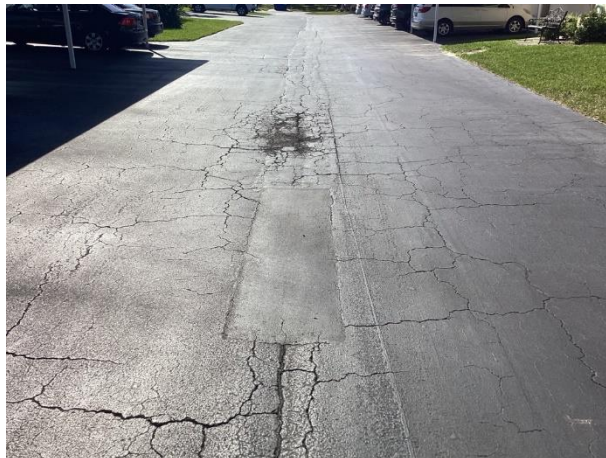
**Pavement overview with cracks and patches**

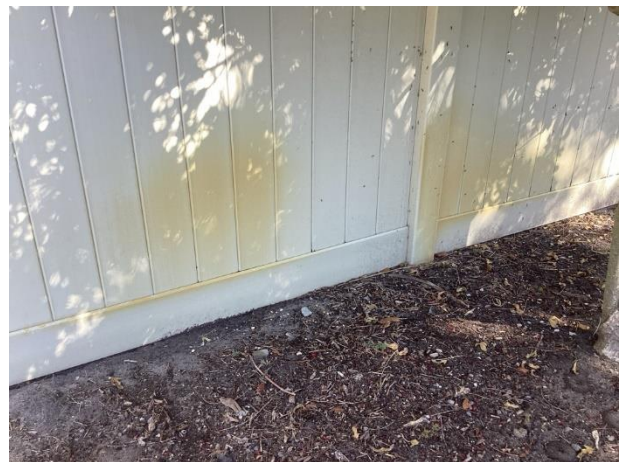
**Condition:** Good to fair overall with isolated stains evident.

Stains at perimeter vinyl fence

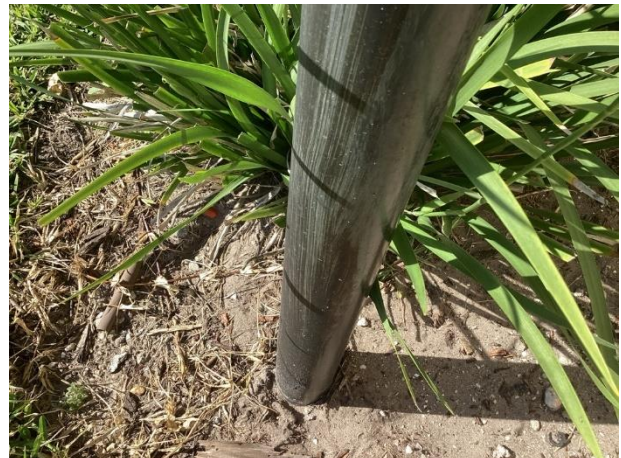
Finish deterioration at light pole

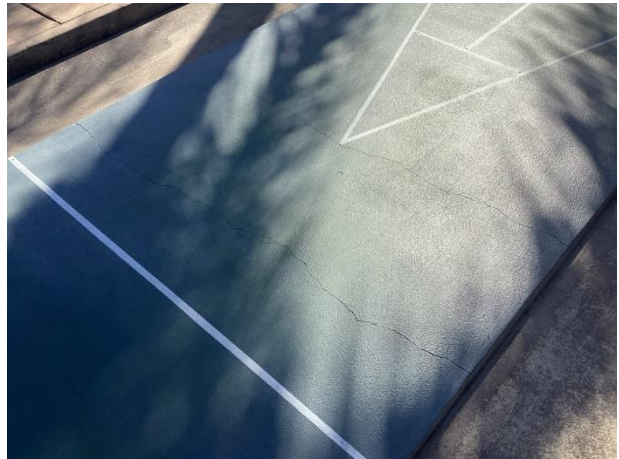
**Condition:** Fair overall with cracks and worn finish evident

Shuffleboard cracks

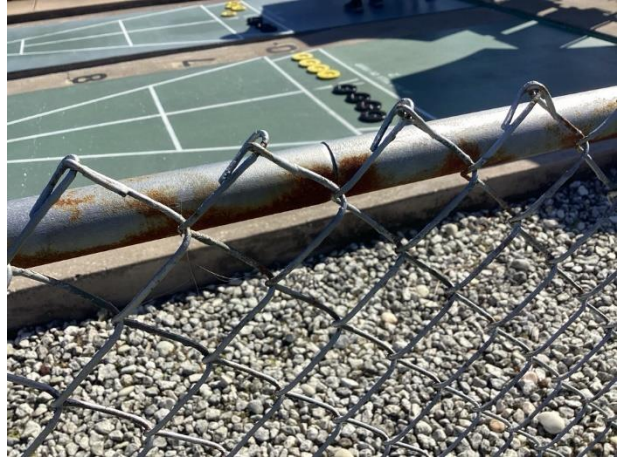
**Condition:** Fair overall with rust evident.

**Fence pole rust**

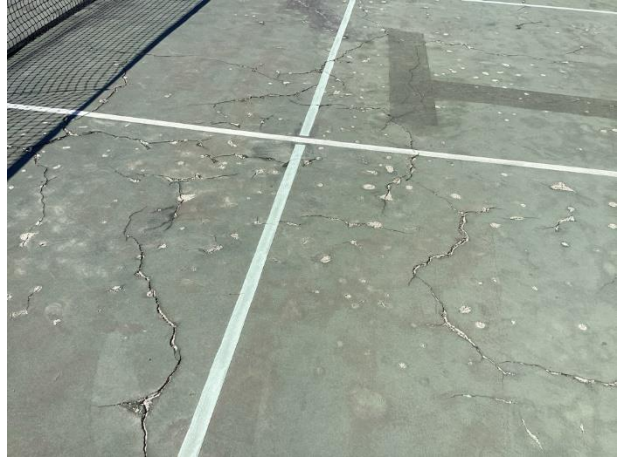
**Condition:** Poor condition

**Surface cracks**

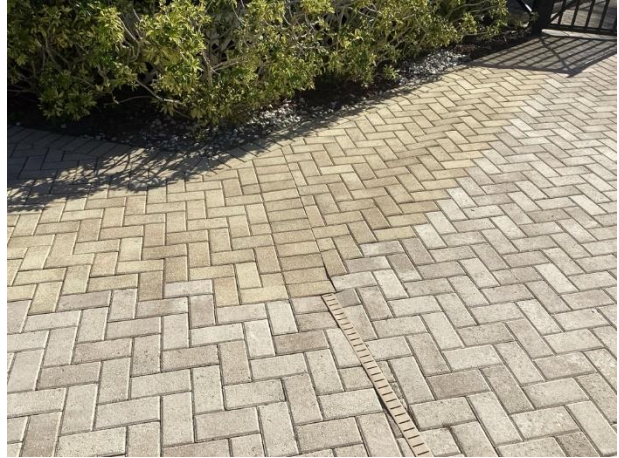
**Previous paver repairs**

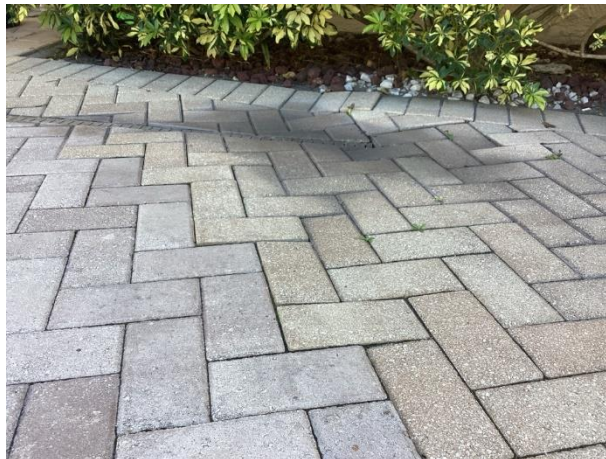
**Condition:** Good to fair overall with isolated minor settlement and previous repairs evident.

**Paver settlement**

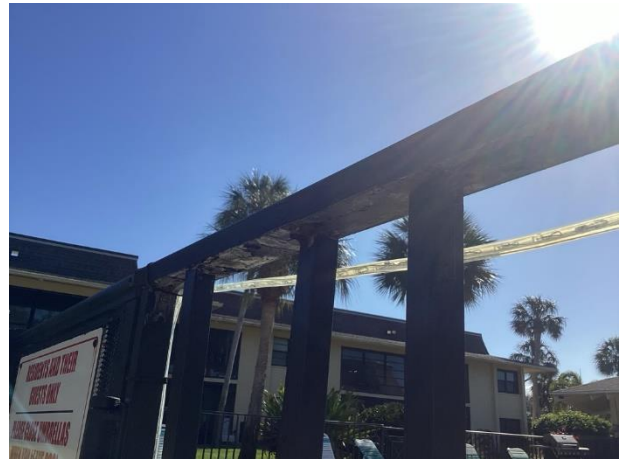
**Condition:** Good to fair overall with isolated damage evident.

Fence damage and previous repair
