MILESTONE PHASE 1 CONDITION SURVEY REPORT

Villas de Golf Condominium – Building 6/7

12300 Vonn Rd., Largo, FL 33774

**Subject: Milestone Phase 1 Structural Condition Survey Report
Villas de Golf Condominium – Building 6/7
12300 Vonn Rd.
Largo, FL 33774**

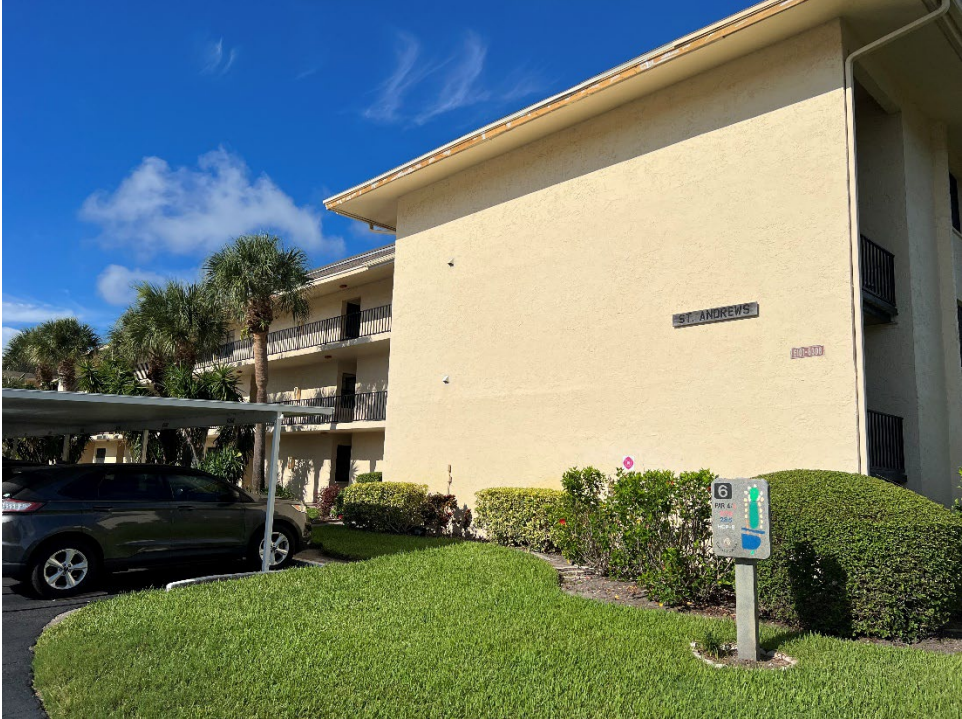
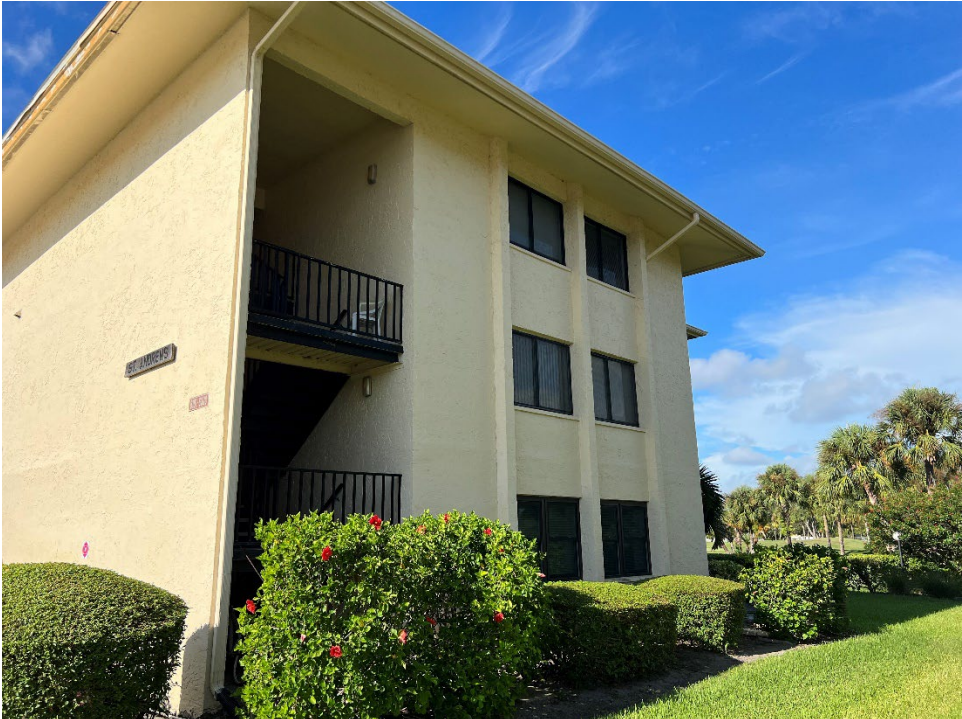
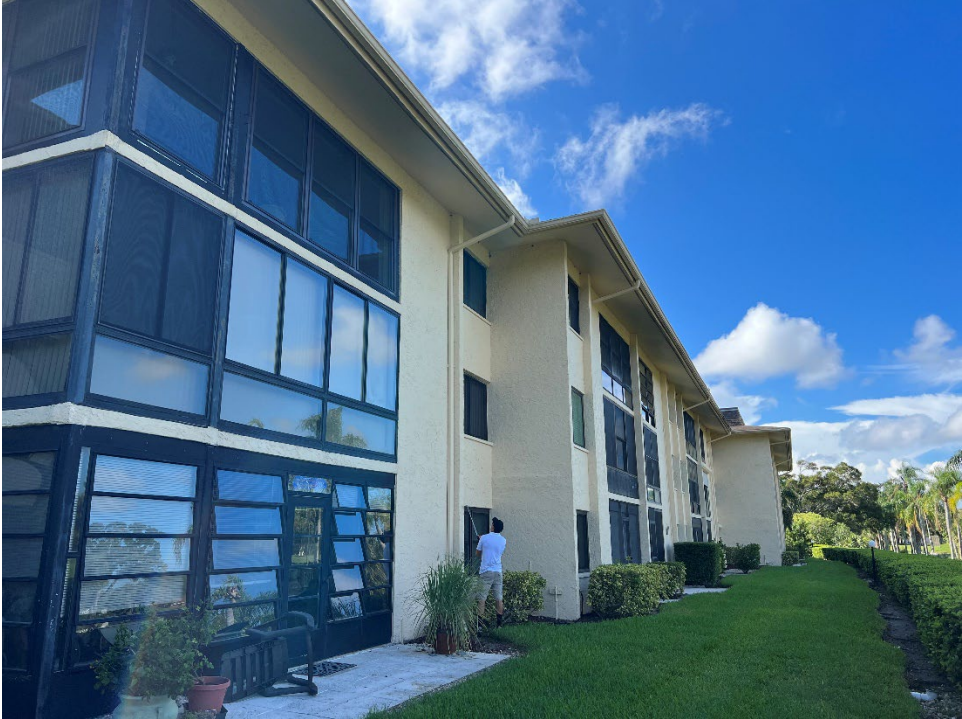
1. Building 6 East elevation, North elevation, and West elevation, exterior wall areas are shown in *Figure A-1* through *Figure A-3*, respectively.
2. Building 7 North elevation, East elevation, and South elevation, exterior wall areas are shown in *Figure A-4* through *Figure A-6*, respectively.

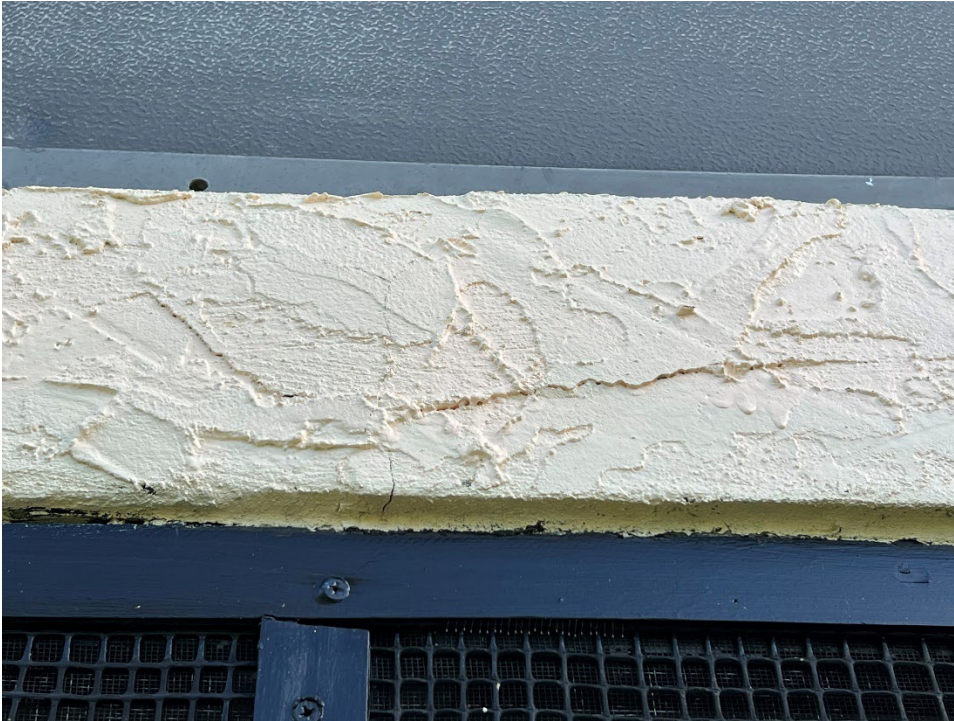
Figure A-7

5. Sporadic areas of hairline cracks were observed throughout the buildings. Refer to *Figure A-7*.
6. Deteriorated sealants were observed around the perimeter of windows throughout the buildings. Refer to *Figure A-8* and *Figure A-9*.

- iv. Concrete crack repair via epoxy injection - cracks in wall surfaces having widths equal to or greater than approximately 1/16".
 - v. Concrete crack repair via routing and sealing with sealant for cracks in concrete wall surfaces having widths less than 1/16" (non-structural cracking).

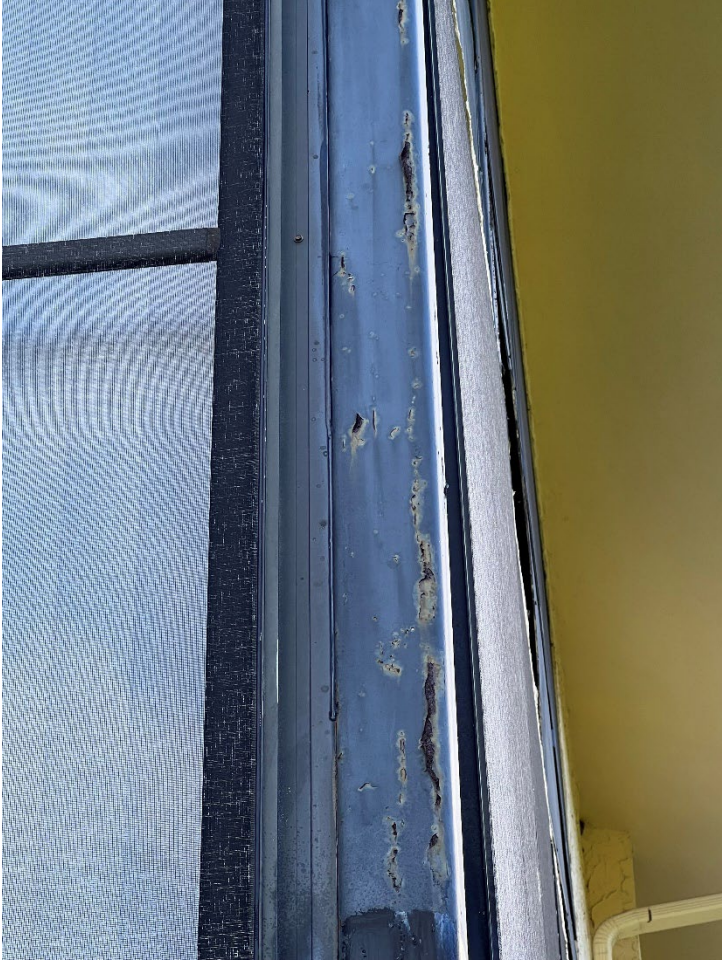
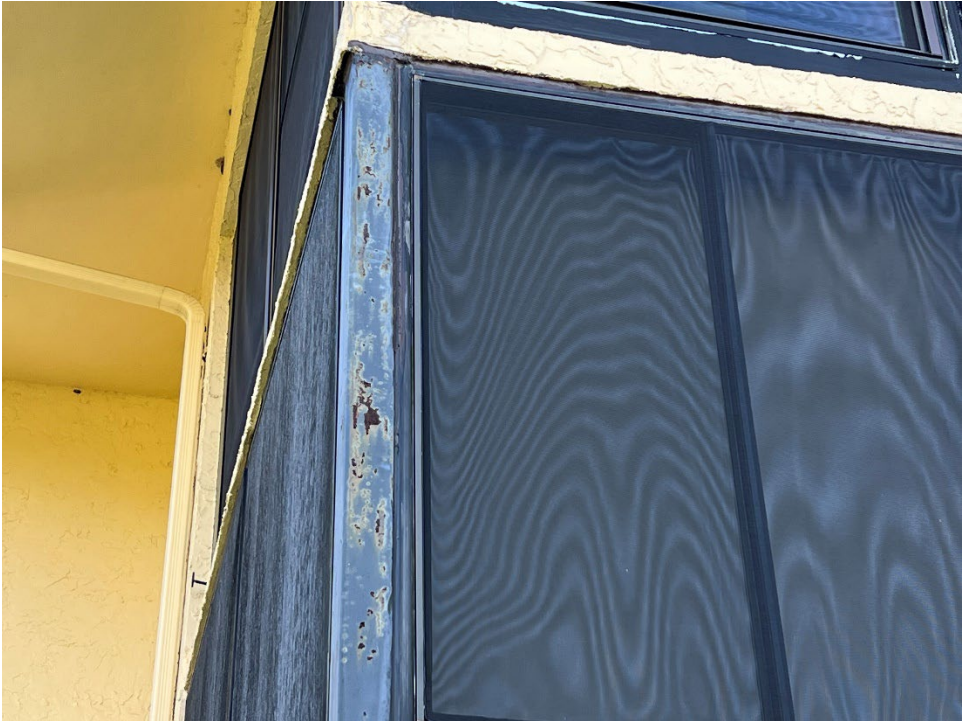
7. Surface corrosion was observed on the steel tube columns at the corner lanais. Refer to *Figure A-10* and *Figure A-11*.
8. Unpainted fascia boards were noted throughout the buildings. Refer to *Figure A-12* and *Figure A-13*.

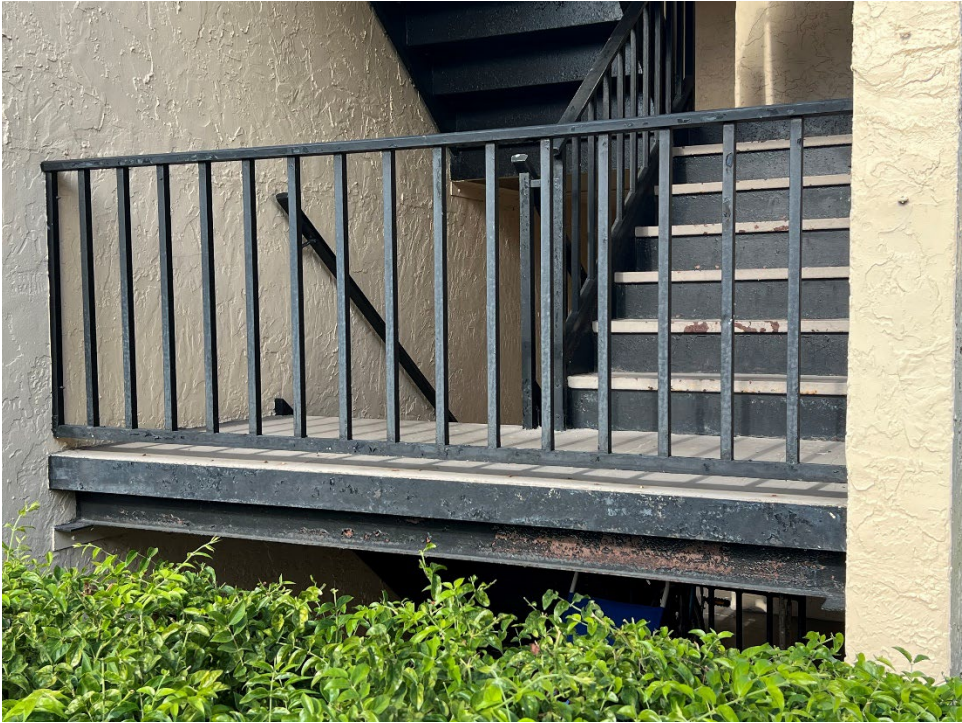
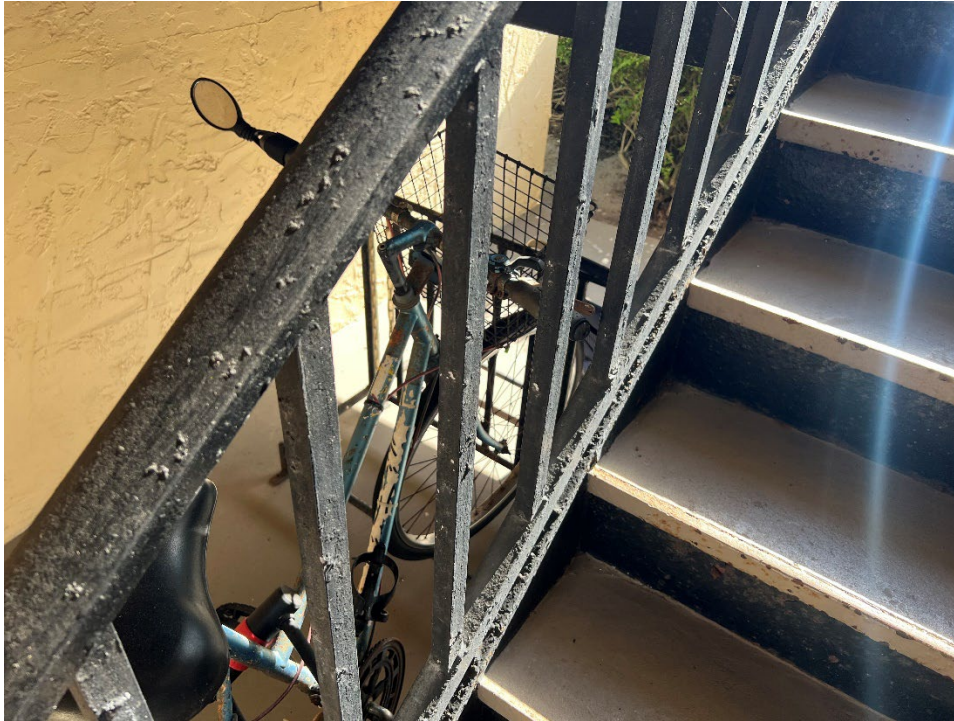
1. All stair railings were made of mechanically attached aluminum.
2. The stair landings and stair treads were a composite concrete and steel deck.
3. Areas on the staircase guardrails and metal framing members were observed to have peeling and deteriorating paint. Refer to *Figure A-14 and Figure A-15*.
4. Isolated locations of corrosion were observed on the staircase metal framing members and railings. *Figure A-16 through Figure A-18*.

The staircase structures appear to be in good condition, with areas of peeling paint and formation of corrosion on the metal elements. BillerReinhart recommends the repair of these items be undertaken concurrently with the walkway restoration and waterproofing project.

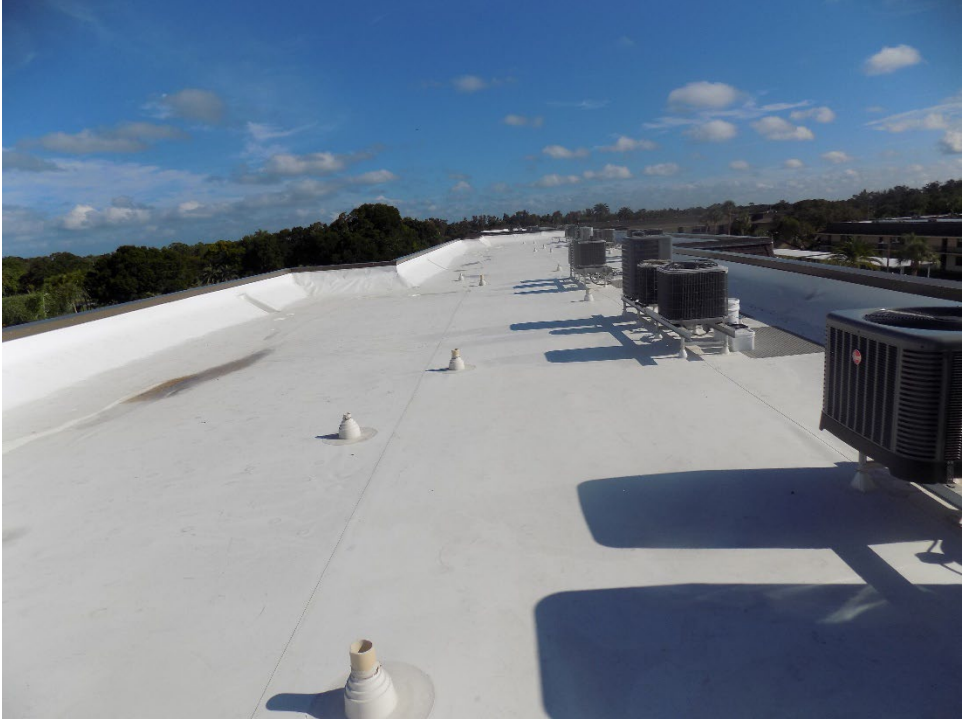
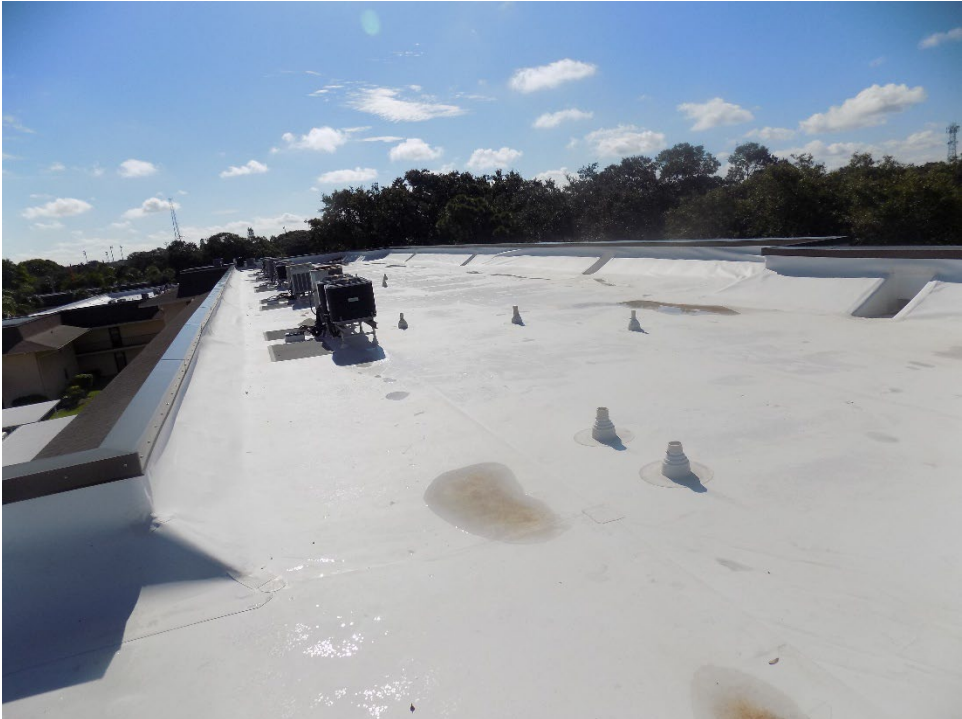
1. Overall general conditions of the roof are shown in *Figure A-19 and Figure A-20*.
2. Multiple shingle with granule loss, exposed fibers, and section loss were observed throughout the roof. Refer to *Figure A-21 through Figure A-23*.
3. Sections of the TPO roof exhibit ridging or wrinkling of the membrane. *Figure A-24 and Figure A-25*.

The roof systems were generally observed to be in good condition with no reports of water intrusion. BillerReinhart understands, construction was completed in 2022 for the roof over with a TPO roof surface with a life expectancy of approximately 20 years and the mansard shingle roof replacement project is planned to start in the following year. BillerReinhart recommends the main TPO roof system be monitored and a replacement project be planned for approximately 2042 and recommends continuing with the planned replacement project of the mansard shingle roof within the following year.

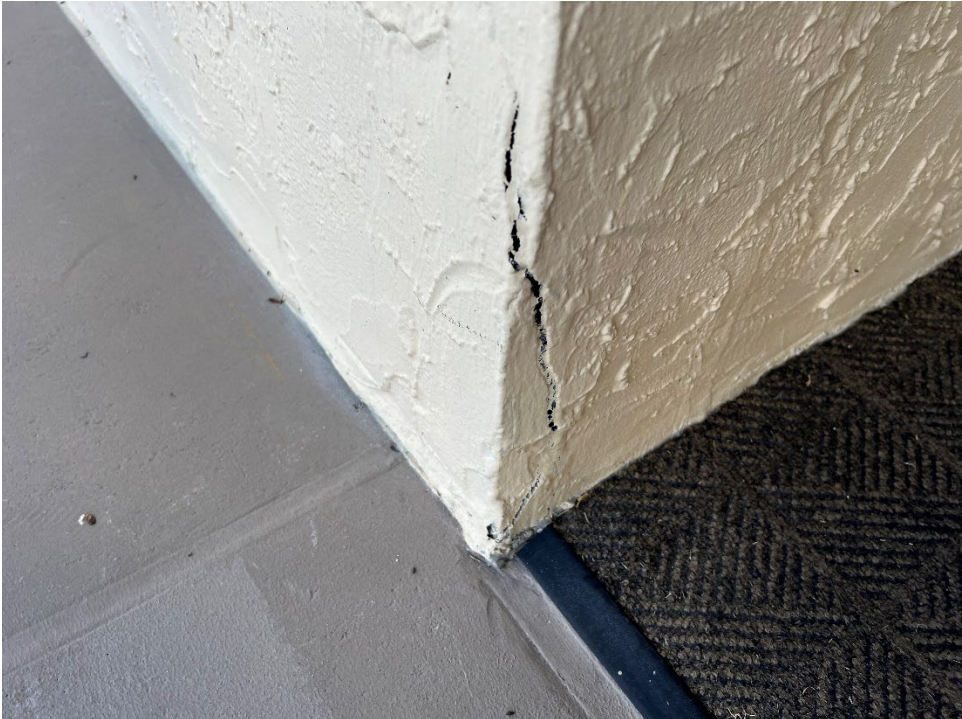
Figure B-6

1. The walkways appear to be covered with coats of paint.
2. The exterior entry areas to unit doors and to the elevators appear to be finished with carpet.
3. The guardrails appear to be mechanically attached aluminum guardrails.
4. Multiple locations of delaminating slab edge were detected throughout the walkways. Refer to *Figure B-1 and Figure B-2*.
5. Multiple delaminations were detected on the ceilings throughout the walkways.
6. Multiple cracks were observed on the walkway slabs and ceilings. Refer to *Figure B-3 through Figure B-5*.
7. Isolated areas of stucco delaminations were detected on the exterior walls of the walkways. Refer to *Figure B-6*.

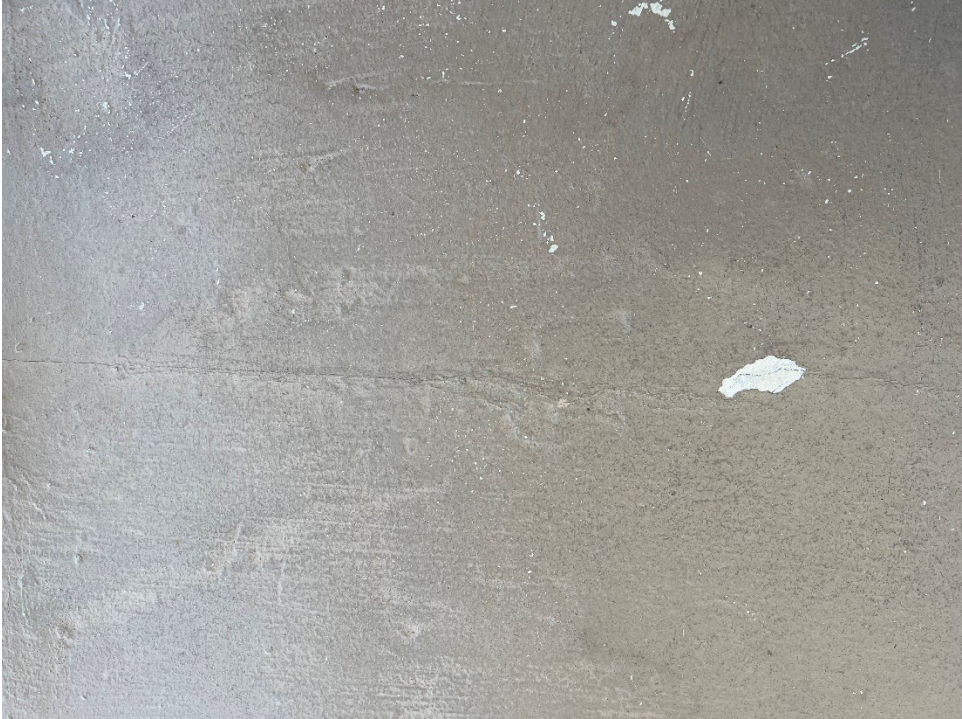
Figure B-7

8. Peeling paint was observed on isolated areas of the walkway slabs. Refer to *Figure B-7*.
9. Supplementary connections were observed to be used to connect the guardrails to the walls. Refer to *Figure B-8*.
10. Corroded fasteners were observed on the guardrail picket connections. Refer to *Figure B-9*.
11. Areas on the guardrails were observed to have peeling and deteriorating paint. Refer to *Figure B-10 through Figure B-12*.
12. The guardrail height appears to be approximately 36 inches and picket spacing of approximately 5 inches.

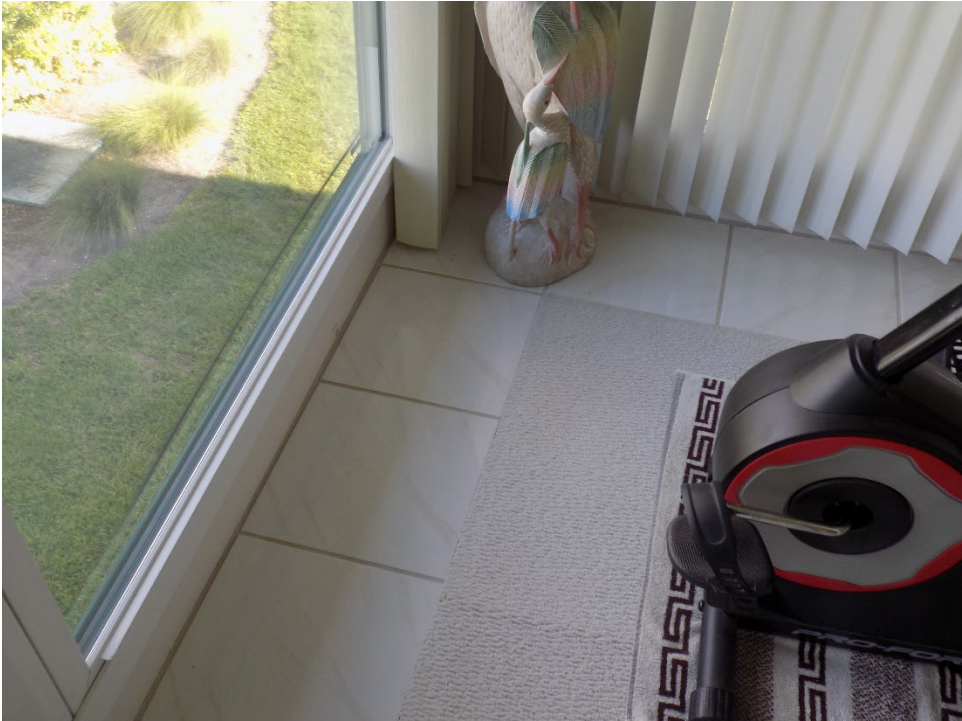
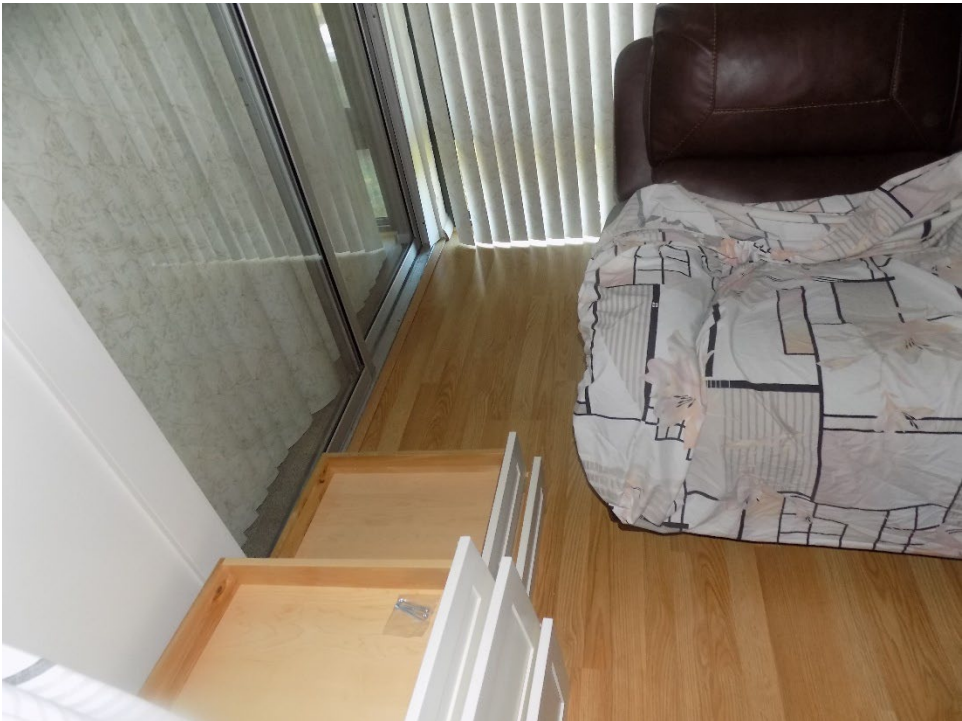
1. A majority of the lanais appear to be enclosed and covered with tile or wood. Overall general conditions of the lanais are shown in *Figure B-13 and Figure B-14*.
2. Cracking with delamination was detected at Unit 7304 lanai beam. Refer to *Figure B-15*.
