# Villas de Golf Condominium Association, Inc.

Inspected: January 31, 2024 • Revised on: December 05, 2024  
Largo, FL

STRUCTURAL INTEGRITY  
RESERVE STUDY

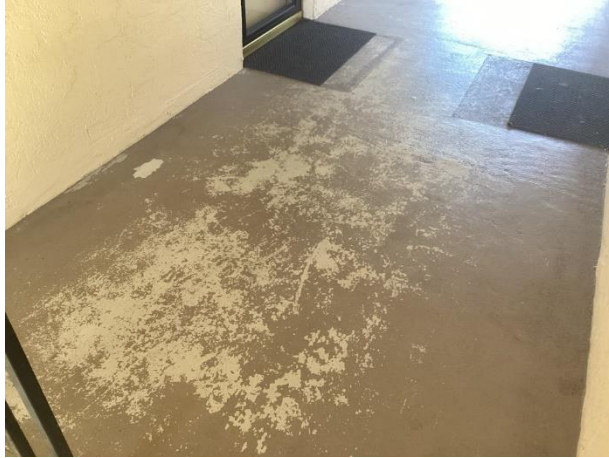
**Delamination by unit 3206**

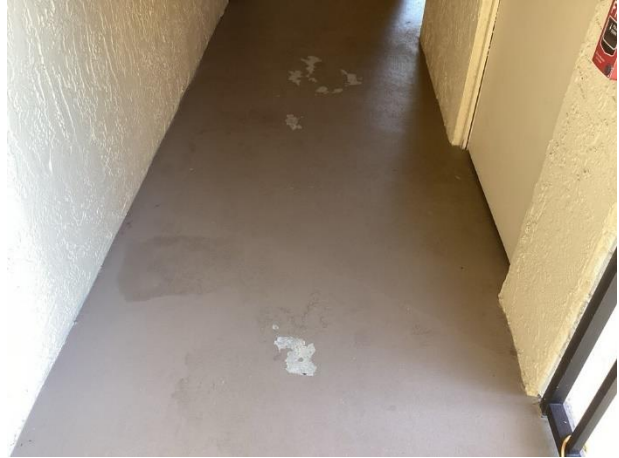
**Coating delamination by unit 4207**

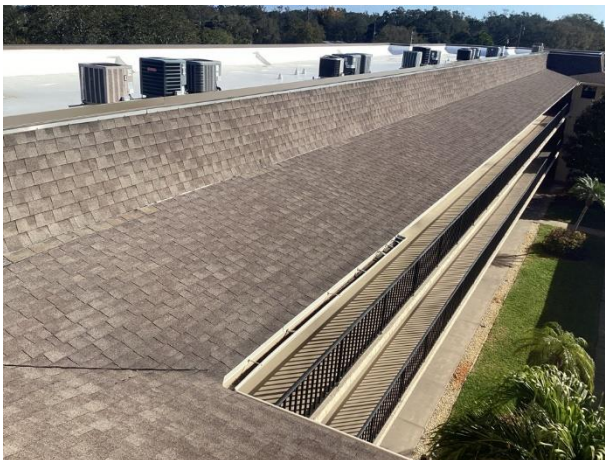
**Condition:** Fair overall with missing shingles and previous repairs evident.

Asphalt shingle roof at residential building

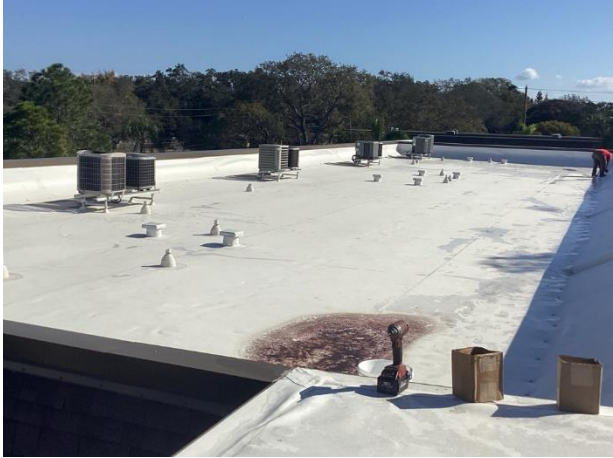
**Roof with isolated area of standing water**

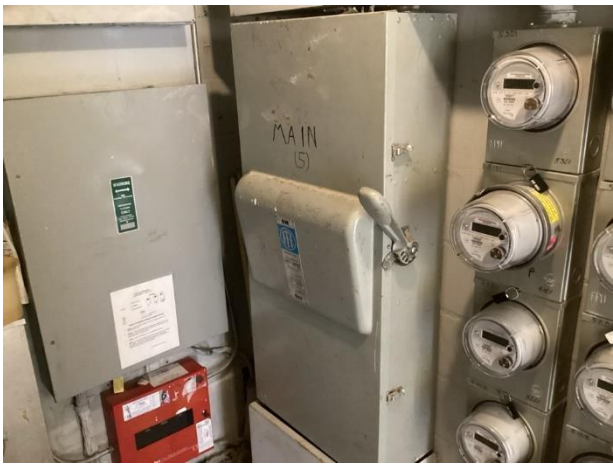
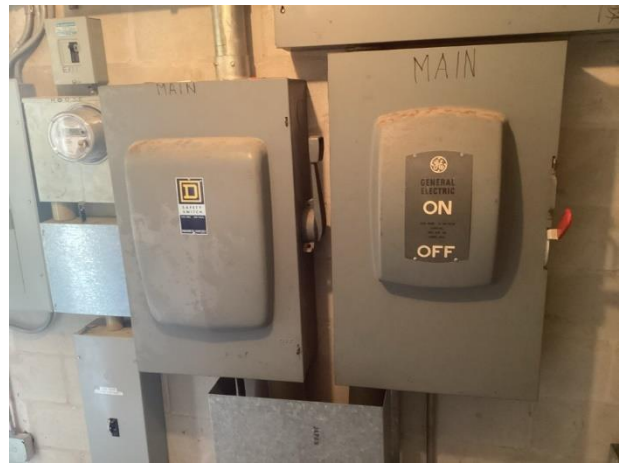
**Condition:** The electrical systems in buildings 1 through 5 are reported satisfactory without operational deficiencies. The systems in buildings 6 through 10 are reported to be in unsatisfactory condition. The Association plans to spend approximately \$70,000 in the near term to replace the electrical panels at buildings 6 through 10. Those replacements will be funded through a special assessment.

Electrical system main panel

Electrical system main panels

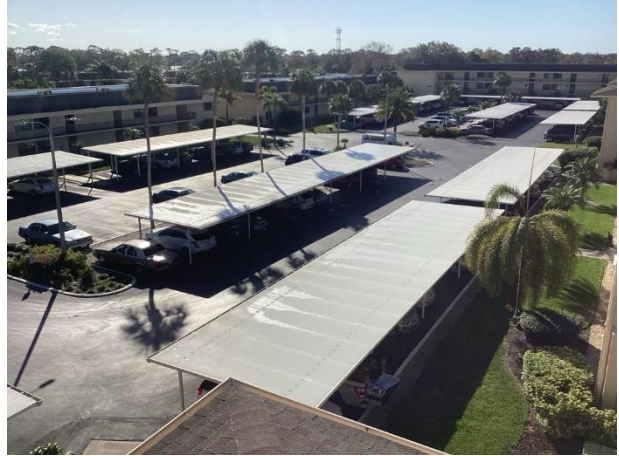
**Carport roofs overview**

**Condition:** Good to fair overall with rust at post evident

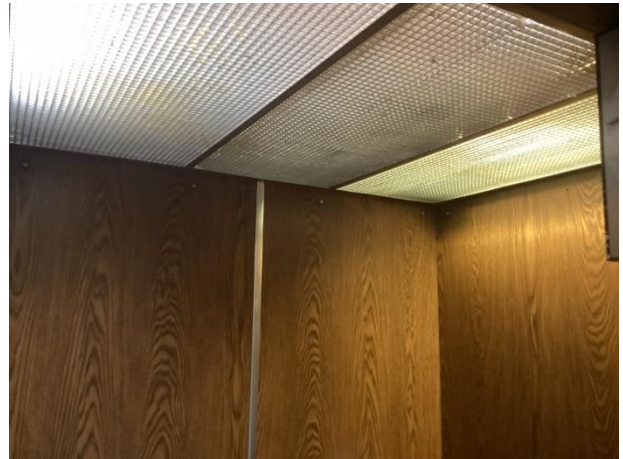
Elevator cab finishes

**Condition:** Fair overall

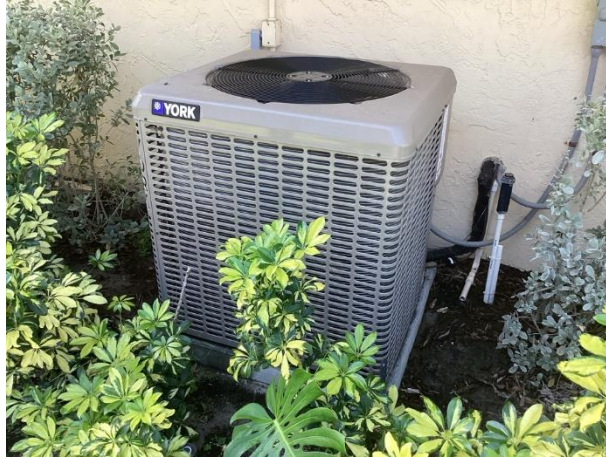
**Split system condenser at clubhouse**

**Condition:** Reported satisfactory without operational deficiencies

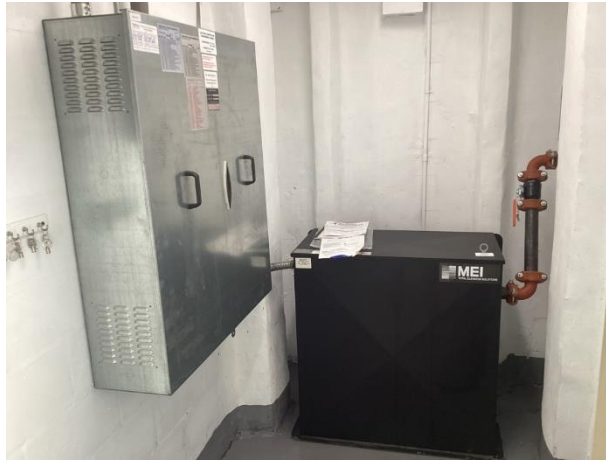
**Hydraulic elevator equipment**

**Condition:** Reported satisfactory

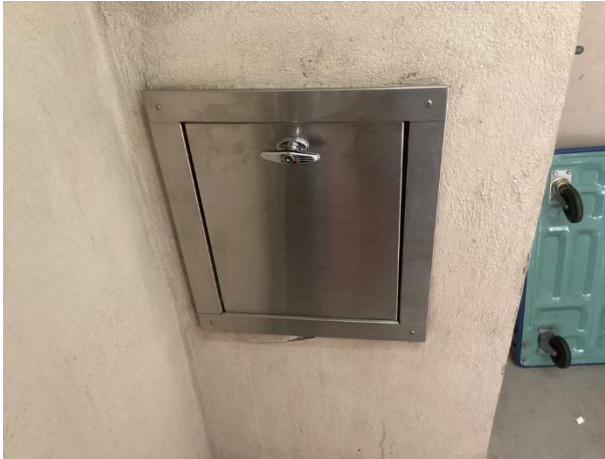
Trash chute door

**Condition:** Reported satisfactory without operational deficiencies

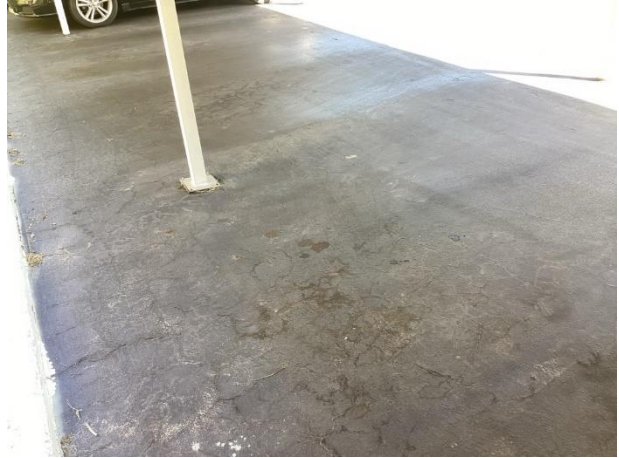
**Pavement under carport**

**Condition:** Fair overall with systemic cracks and patches evident.

The manner of repaving is either a mill and overlay or total replacement. A mill and overlay is a method of repaving where cracked, worn and failed pavement is mechanically removed or milled until sound pavement is found. A new layer of asphalt is overlaid atop the remaining base course of pavement. Total replacement includes the removal of all existing asphalt down to the base course of aggregate and native soil followed by the application of two or more new lifts of asphalt. We recommend mill and overlayment on asphalt pavement that exhibits normal deterioration and wear. We recommend total replacement of asphalt pavement that exhibits severe deterioration, inadequate drainage, pavement that has been overlaid multiple times in the past or where the configuration makes overlayment not possible. Based on the apparent visual condition and configuration of the asphalt pavement, we recommend the mill and overlay method of repaving at Villas de Golf.

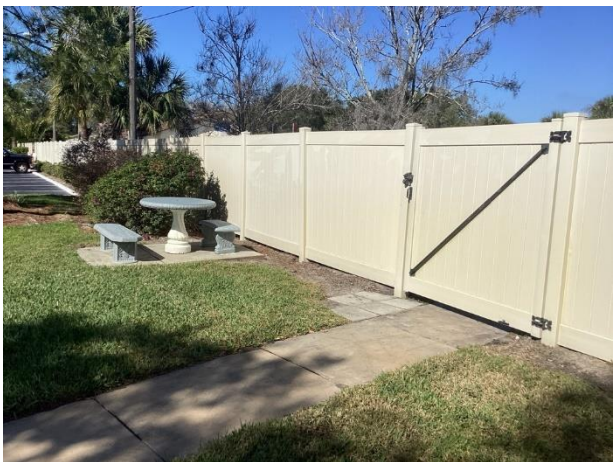
Vinyl fence at north perimeter

**Condition:** Good to fair overall with isolated stains evident.

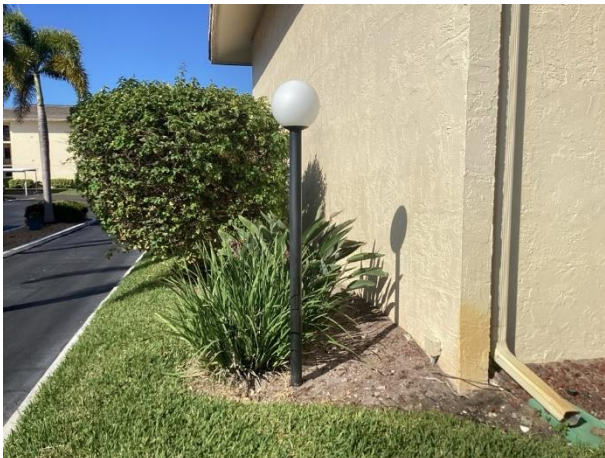
Light pole and fixture

**Condition:** Good to fair overall with finish deterioration evident.

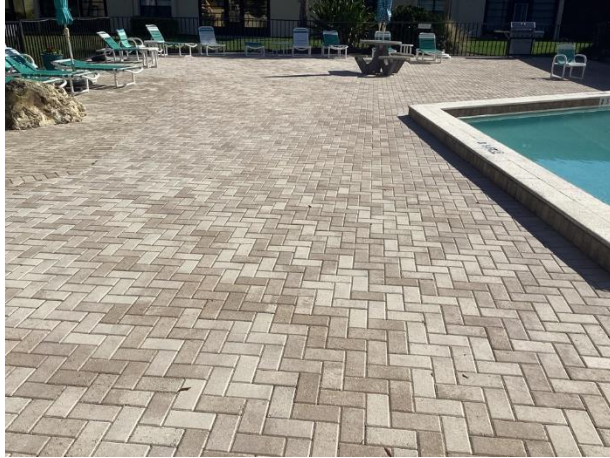
**Paver pool deck overview**

**Condition:** Good to fair overall with isolated minor settlement and previous repairs evident.

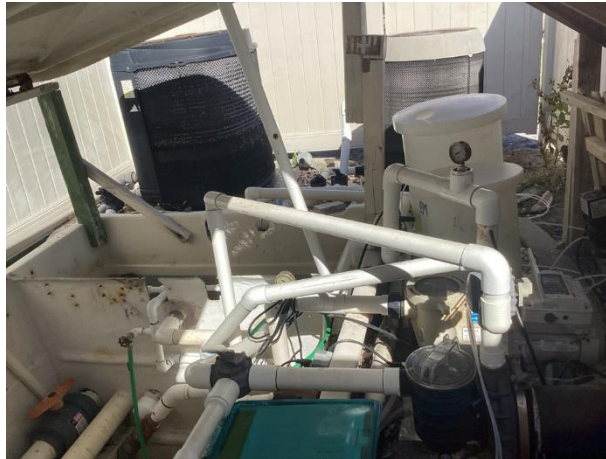
Pool mechanical equipment

**Condition:** Reported satisfactory without operational deficiencies
