# Villas de Golf Condominium Association, Inc.

Inspected: January 31, 2024 • Revised on: December 05, 2024  
Largo, FL

STRUCTURAL INTEGRITY  
RESERVE STUDY

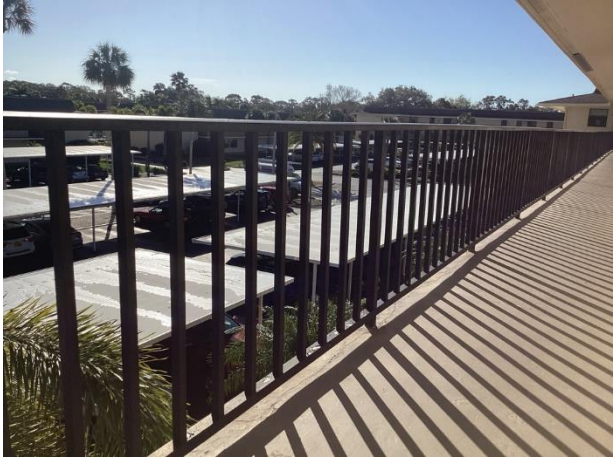
**Conditions:** The railings are in fair overall condition and the railing finishes are in poor condition with rust and peeling finish evident.

**Aluminum railings at breezeway**

**Useful Life:** Railings of this type have a useful life of up to 50 years with the benefit of periodic maintenance. Periodic maintenance should include applications of a protective paint finish and partial replacement of deteriorated aluminum every five- to seven-years.

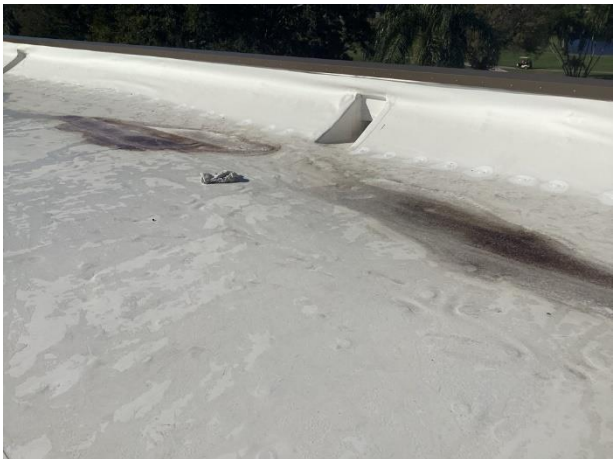
**Standing water**

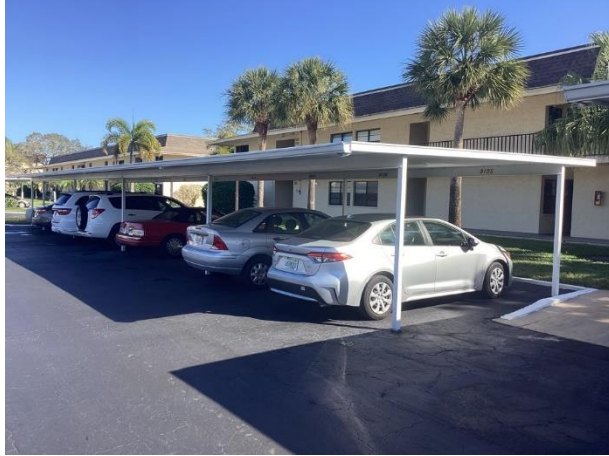
**Carport**

**Condition:** Good to fair overall with rust at post evident

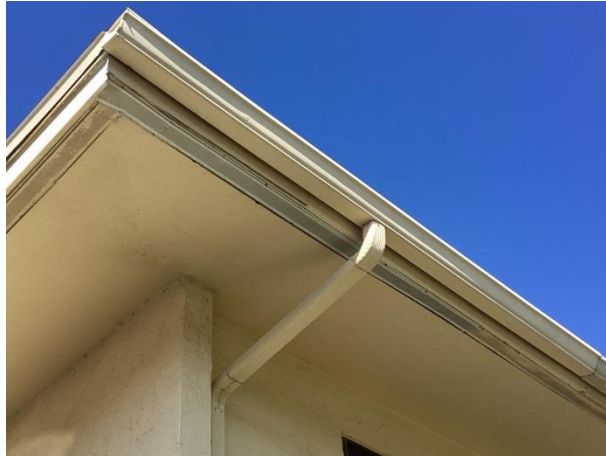
**Aluminum gutter and downspout**

**History and Condition:** The age was unavailable at the time of our inspection. The Association plans to replace the gutters and downspouts with a larger capacity system in the near term since the current system is reported to be inadequate. The project will be funded through a special assessment. The estimate of cost is based on information provided by Management and the Board.

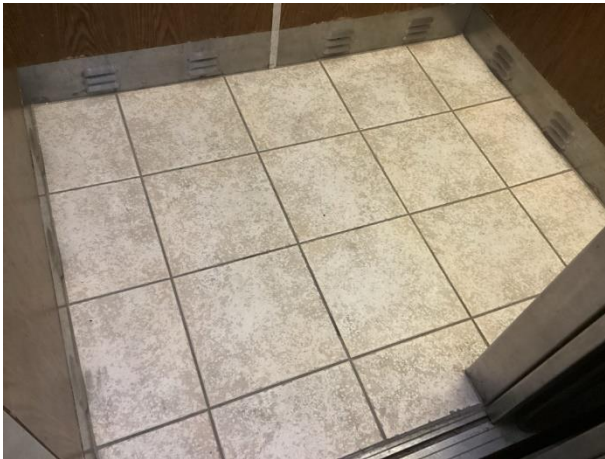
Cab floor coverings

**Condition:** Fair overall

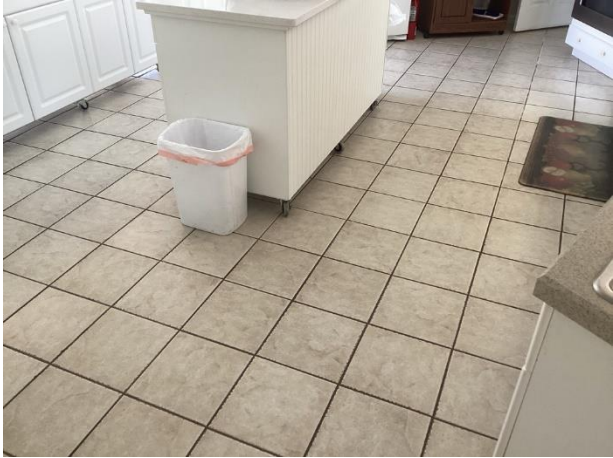
**Tile floor at clubhouse**

**Condition:** Good to fair overall

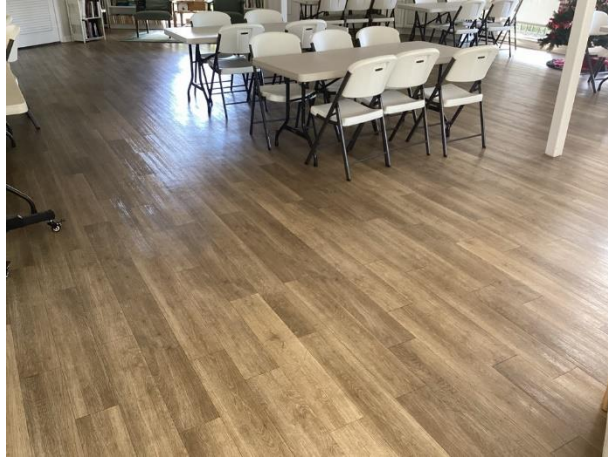
Laminate floor at clubhouse

**Condition:** Good overall

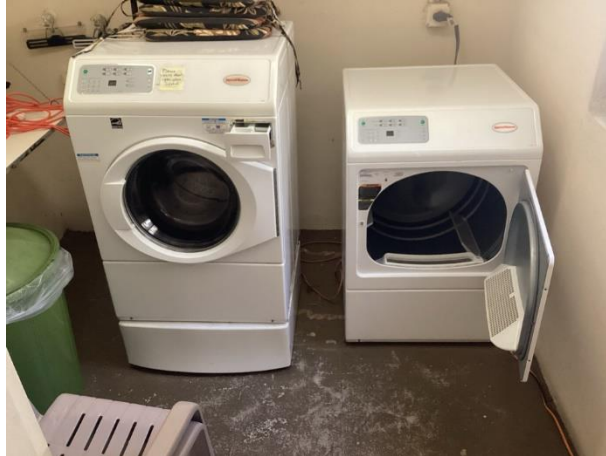
**Laundry equipment**

**Condition:** Reported satisfactory without operational deficiencies

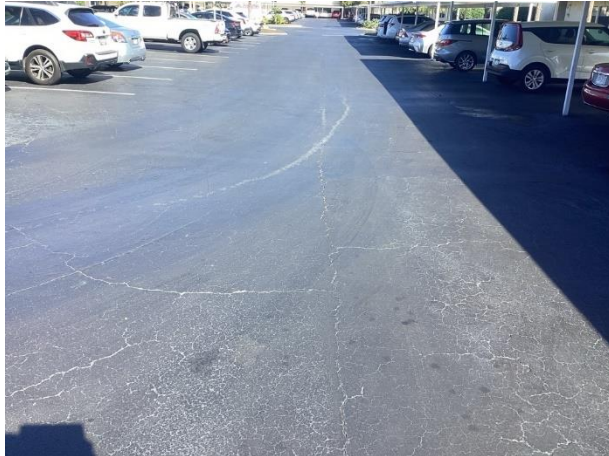
Pavement overview

**Condition:** Fair overall with systemic cracks and patches evident.

The manner of repaving is either a mill and overlay or total replacement. A mill and overlay is a method of repaving where cracked, worn and failed pavement is mechanically removed or milled until sound pavement is found. A new layer of asphalt is overlaid atop the remaining base course of pavement. Total replacement includes the removal of all existing asphalt down to the base course of aggregate and native soil followed by the application of two or more new lifts of asphalt. We recommend mill and overlayment on asphalt pavement that exhibits normal deterioration and wear. We recommend total replacement of asphalt pavement that exhibits severe deterioration, inadequate drainage, pavement that has been overlaid multiple times in the past or where the configuration makes overlayment not possible. Based on the apparent visual condition and configuration of the asphalt pavement, we recommend the mill and overlay method of repaving at Villas de Golf.

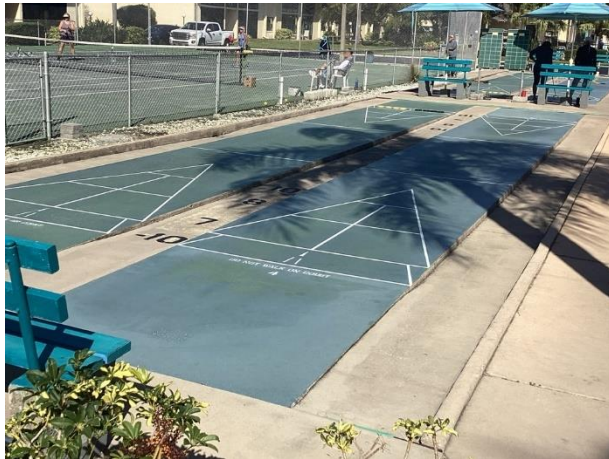
Shuffleboard courts overview

**Condition:** Fair overall with cracks and worn finish evident

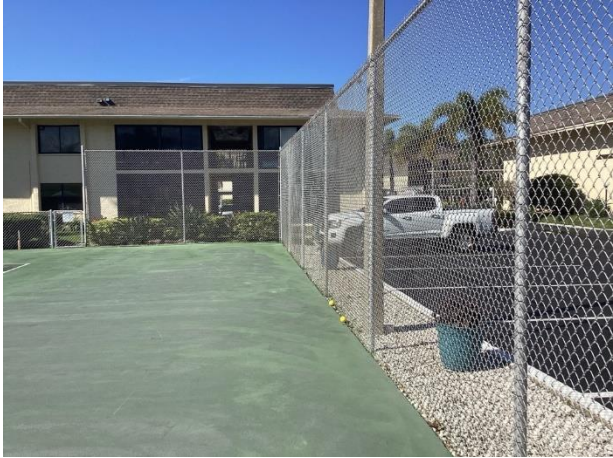
**Condition:** Fair overall with rust evident.

**Chain link fence at tennis court**

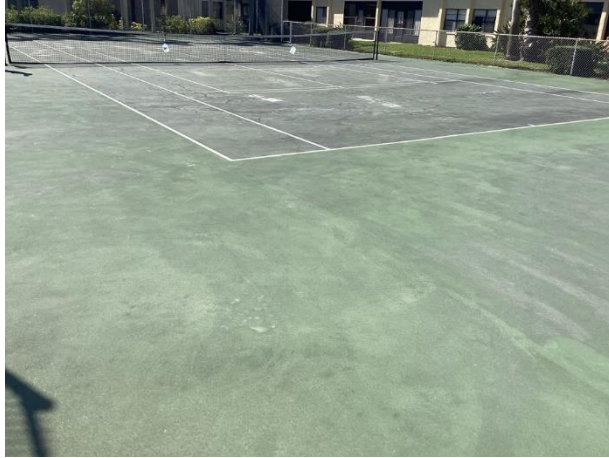
**Tennis court overview**

**History:** The age was unavailable at the time of our inspection. We include a near term expenditure for complete resurfacing of the courts based on information provided by the Board.

**Condition:** Poor condition

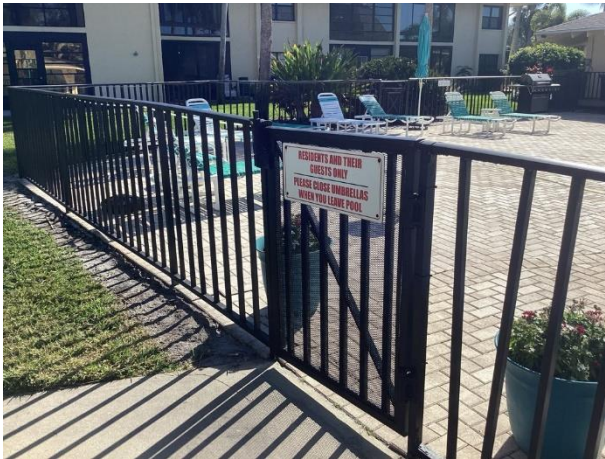
Aluminum pool fence

**Condition:** Good to fair overall with isolated damage evident.

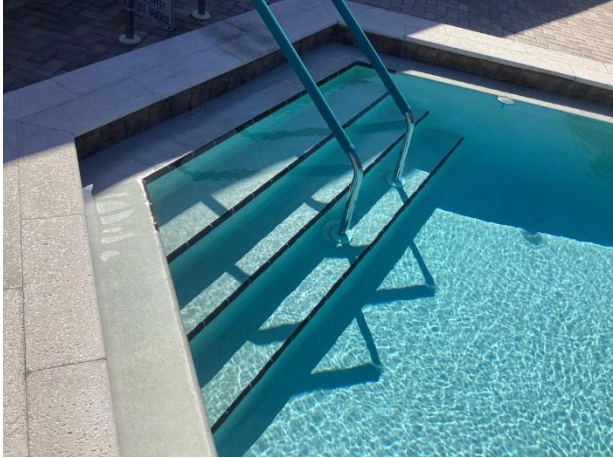
**Pool plaster finish with tile perimeter**

**Condition:** Good to fair overall
